## Investigation Report

Published: June 12, 2019

On January 22, 2018, a blowout and rig fire occurred at Pryor Trust 0718 gas well number 1H-9, located in Pittsburg County, Oklahoma. The fire killed five workers, who were inside the driller's cabin on the rig floor. They died from thermal burn injuries and smoke and soot inhalation. The blowout occurred about three-and-a-half hours after removing drill pipe ("tripping") out of the well.

# Gas Well Blowout and Fire at Pryor Trust Well 1H-9

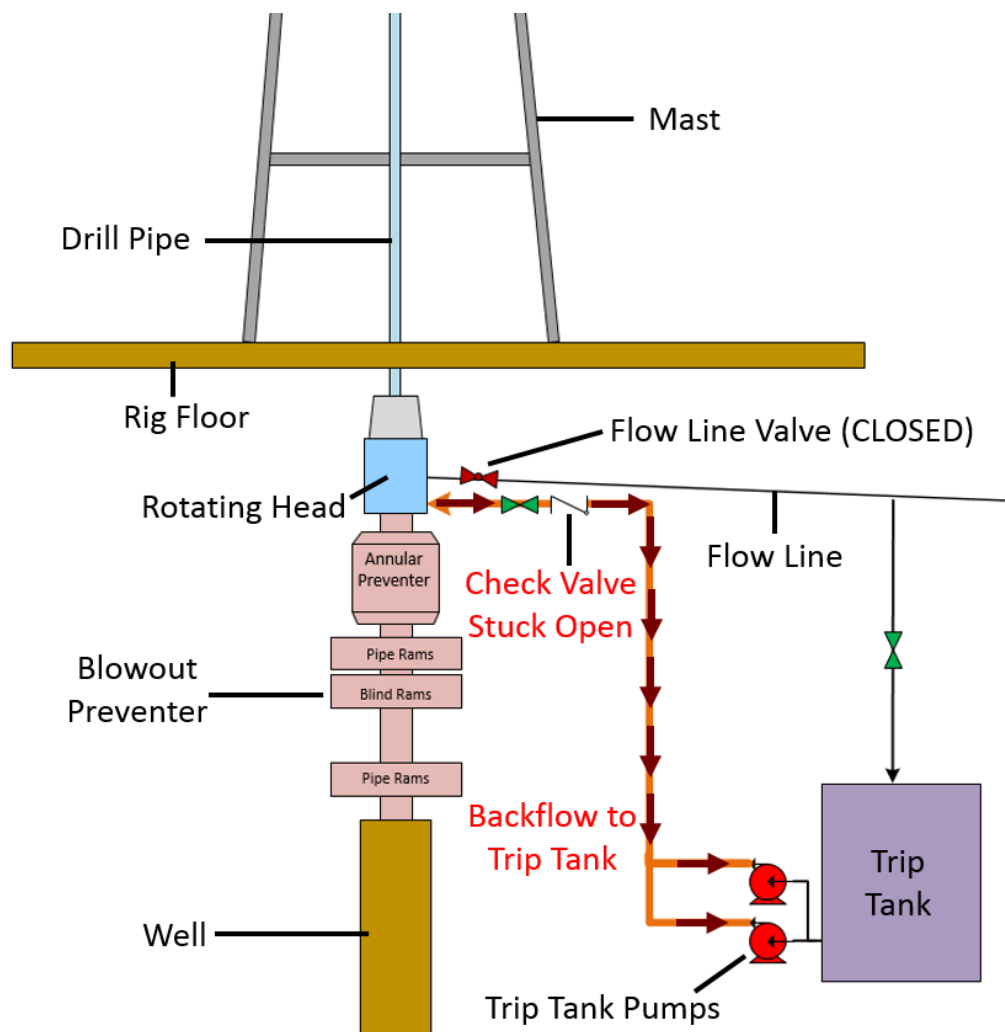
Figure 14. Pressurized mud backflowed through trip tank discharge piping, stuck-open check valve, and centrifugal pumps into trip tank.

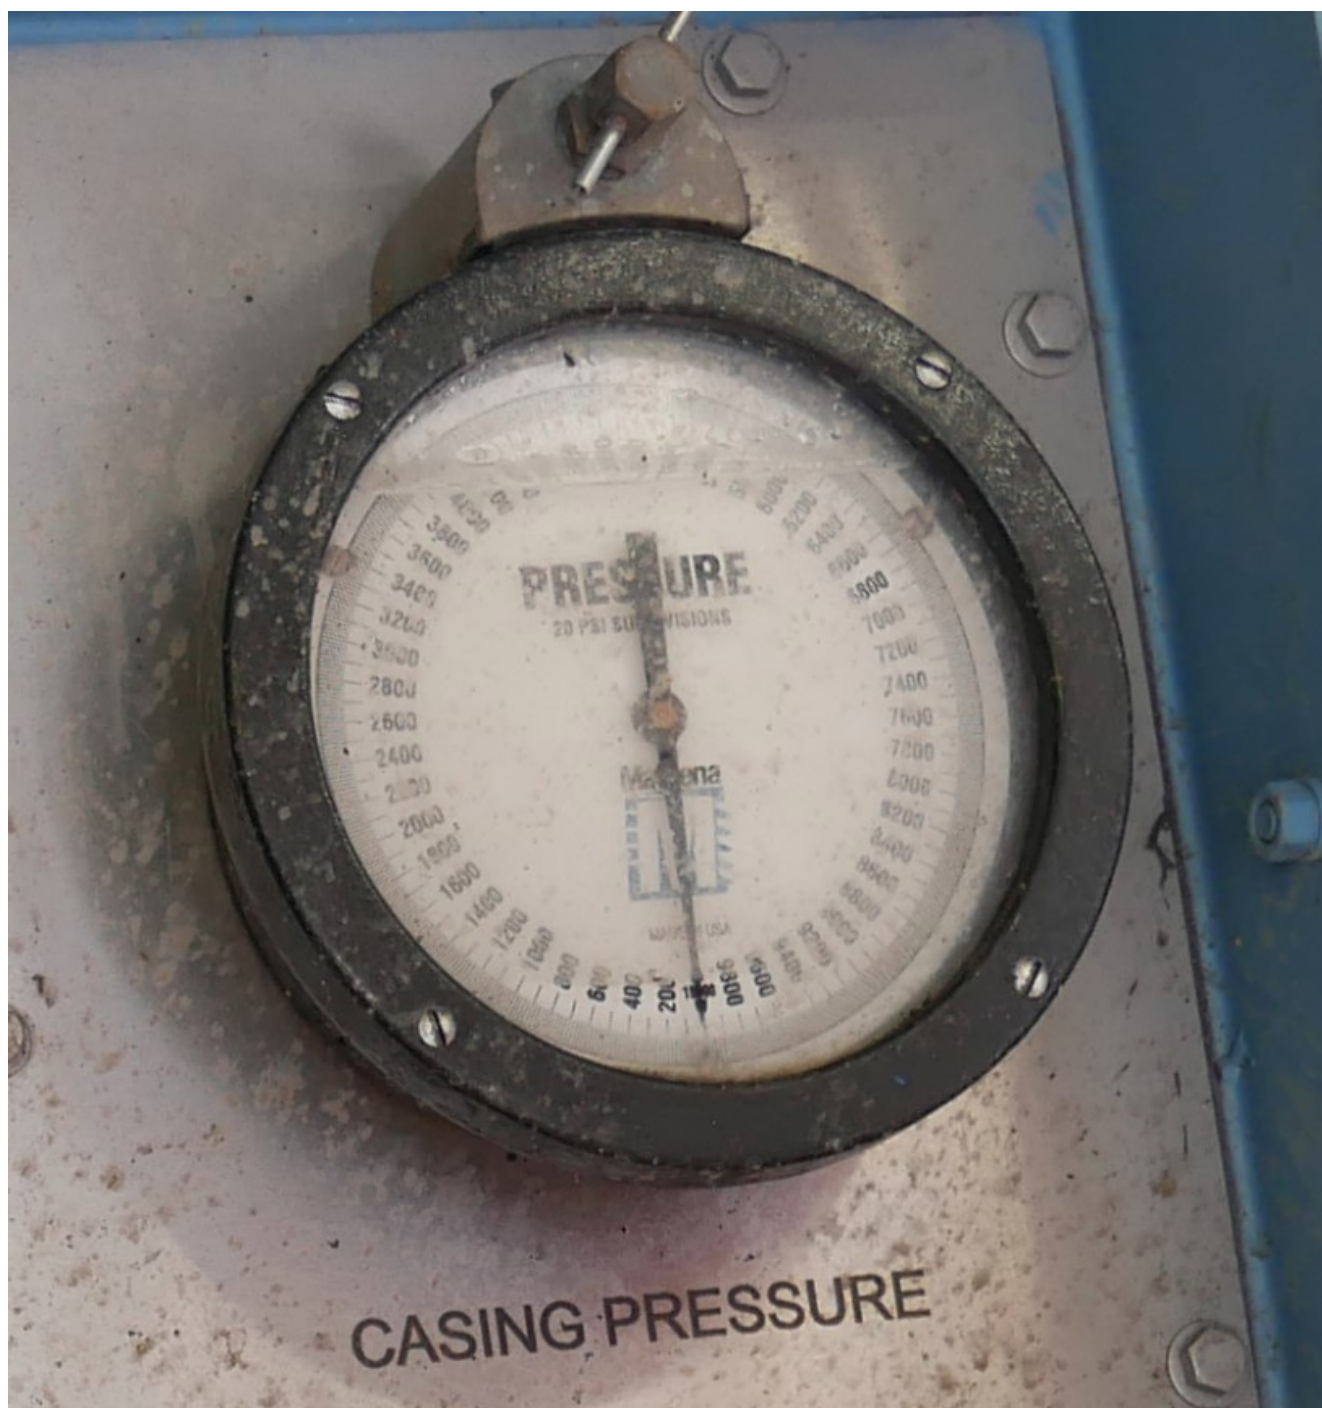
Figure 16. Photo of casing pressure gauge on an exemplar Patterson drilling rig. The pressure gauge could indicate pressures up to 10,000 psi. Low pressures might have been difficult to read on the Rig 219 pressure gauge, or the pressure gauge might not have worked properly at low pressures. The valve on the choke system (“HCR valve”) that needed to be opened to measure annular pressure might have been closed during pressure readings, or the line might have been plugged.

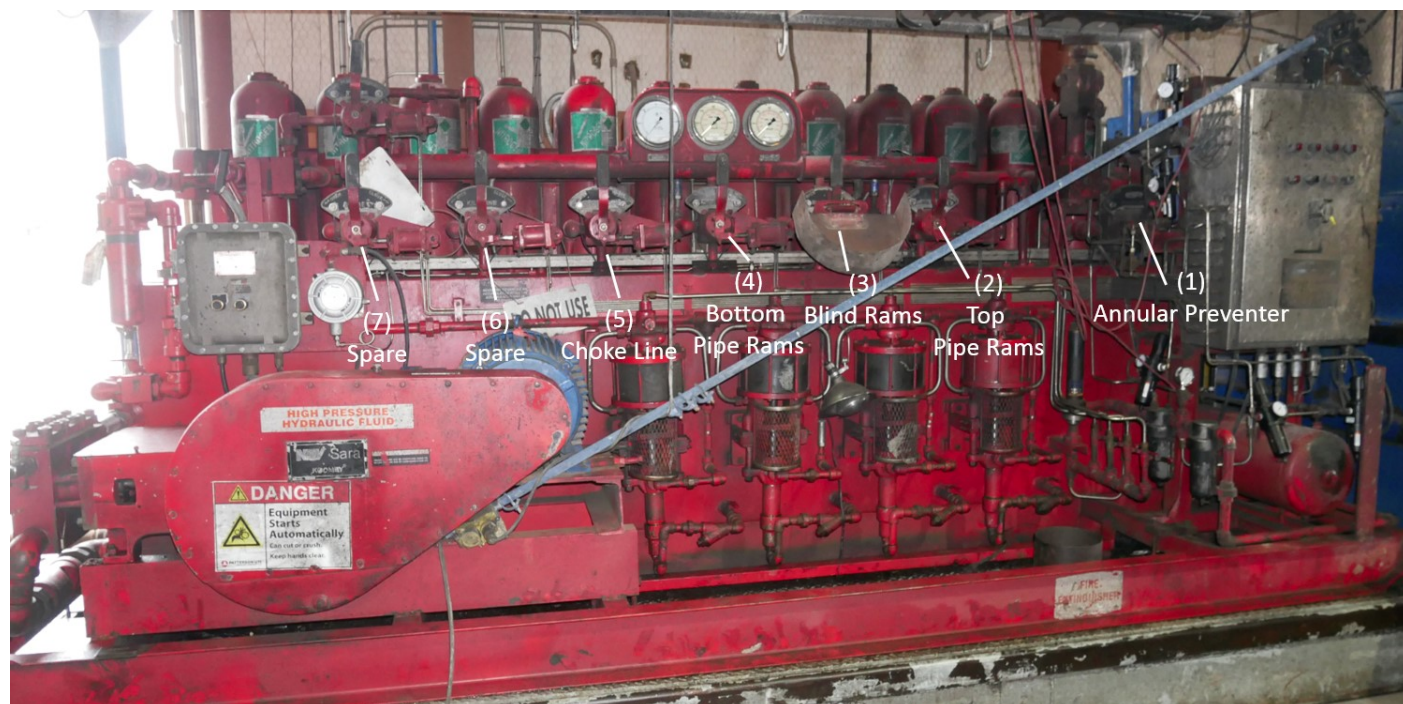
Figure 31. Photo of the BOP accumulator, which is used to function the BOP rams. The rig manager closed the BOP control handles in the following order: (1) annular preventer, (2) top pipe rams, (3) blind rams, and (4) bottom pipe rams. The blowout preventer did not seal the well to stop the blowout when the rig manager functioned the control handles.

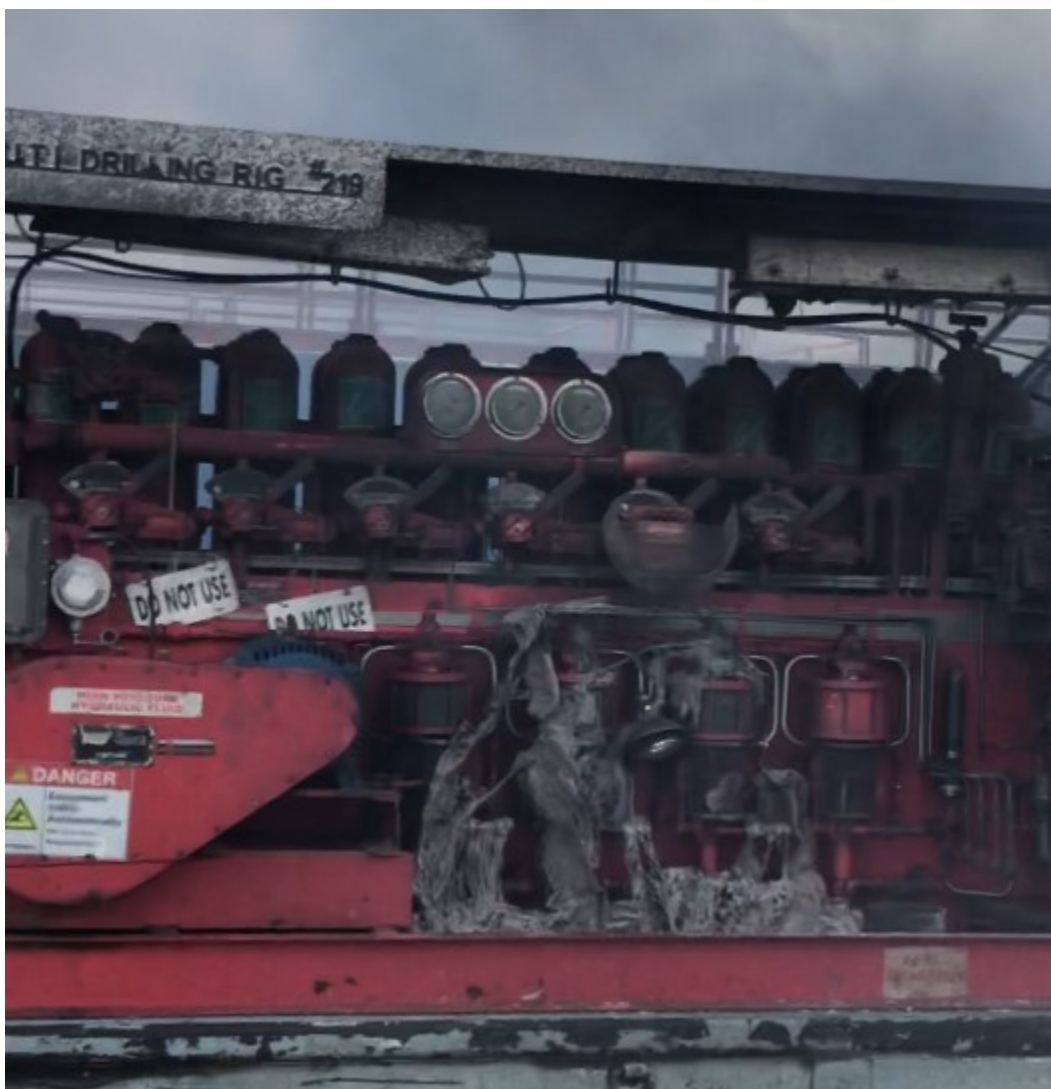
*Figure 32. Video captured at 11:51 am on January 22, 2018 shows all BOP handles in the closed position.*

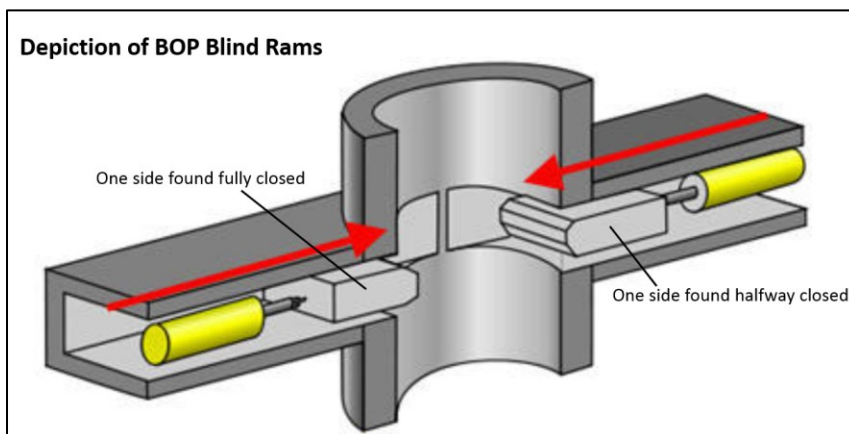
Figure 33. Depiction of BOP blind rams. A Boots & Coots responder found that the south-side blind ram was fully closed, and the north-side blind ram was halfway closed. Source: *drillingformulas.com* [11] with notations by CSB.

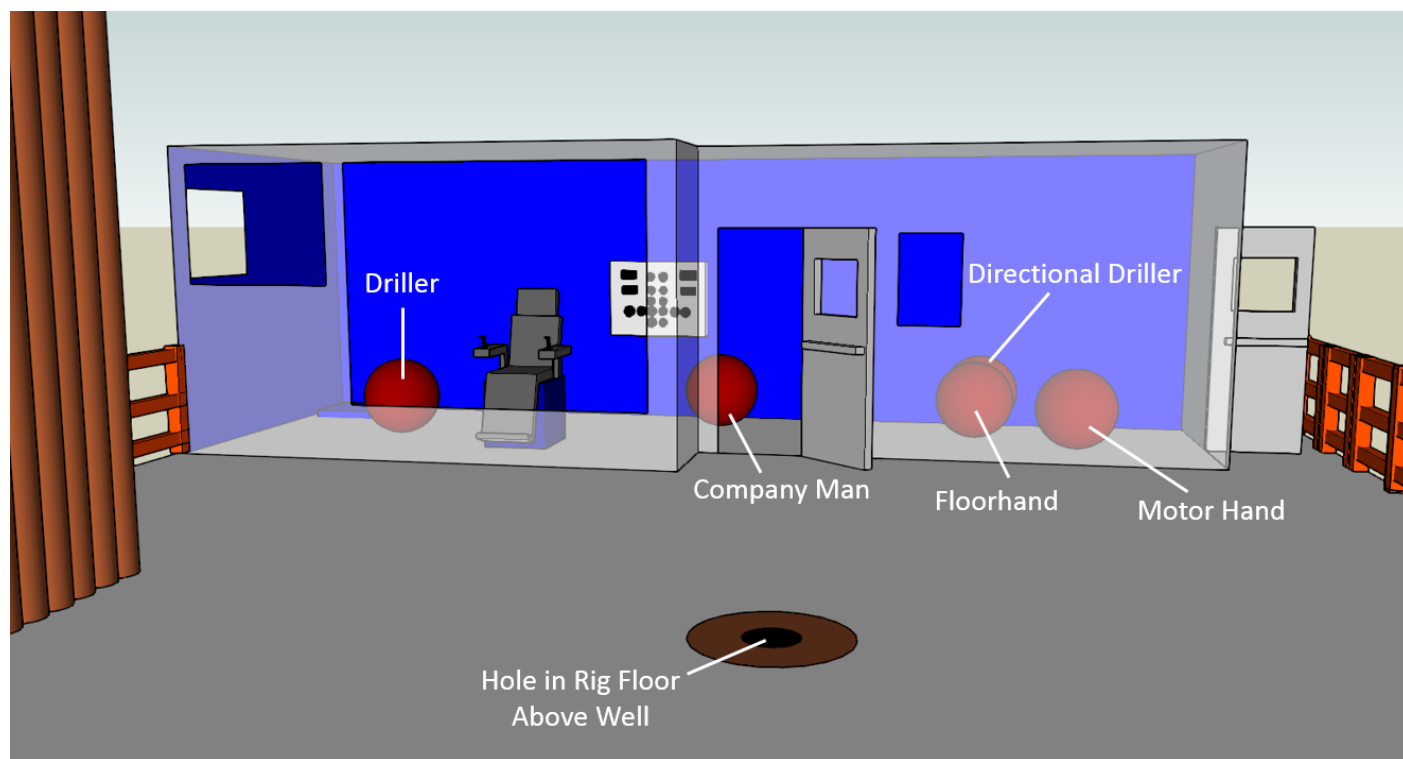
Figure 42. Locations where victims were found in the driller's cabin

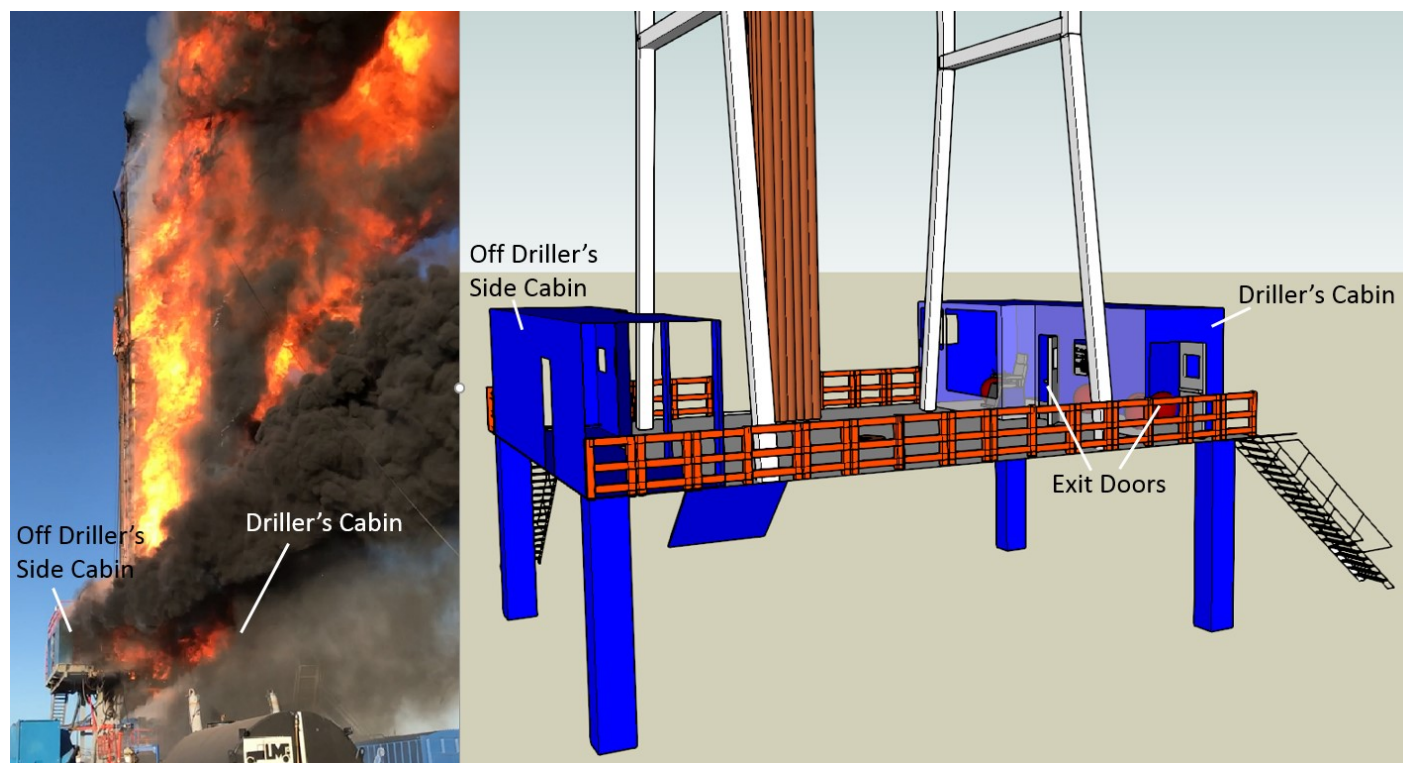
Figure 44. Both exits from the driller's cabin were engulfed by fire.

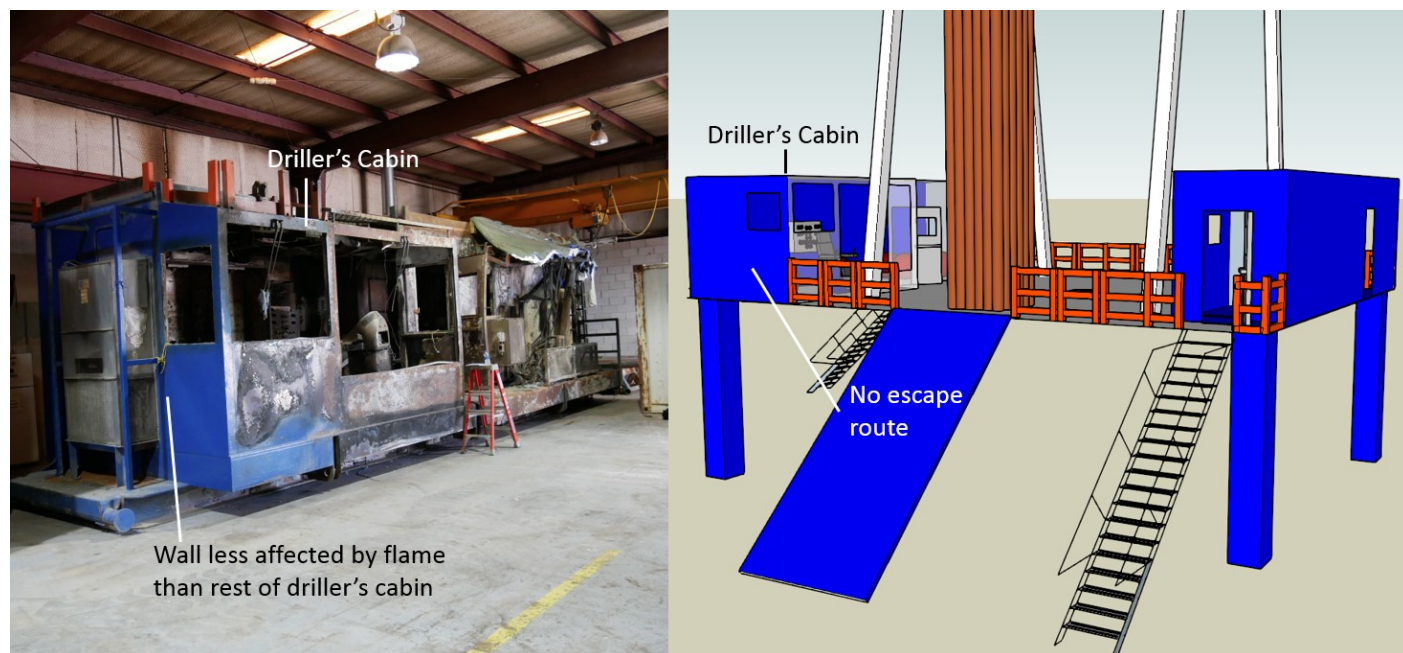
Figure 45. One part of the driller's cabin appeared to be less affected by fire, evident by the paint remaining post-incident. There was no escape route near that location.

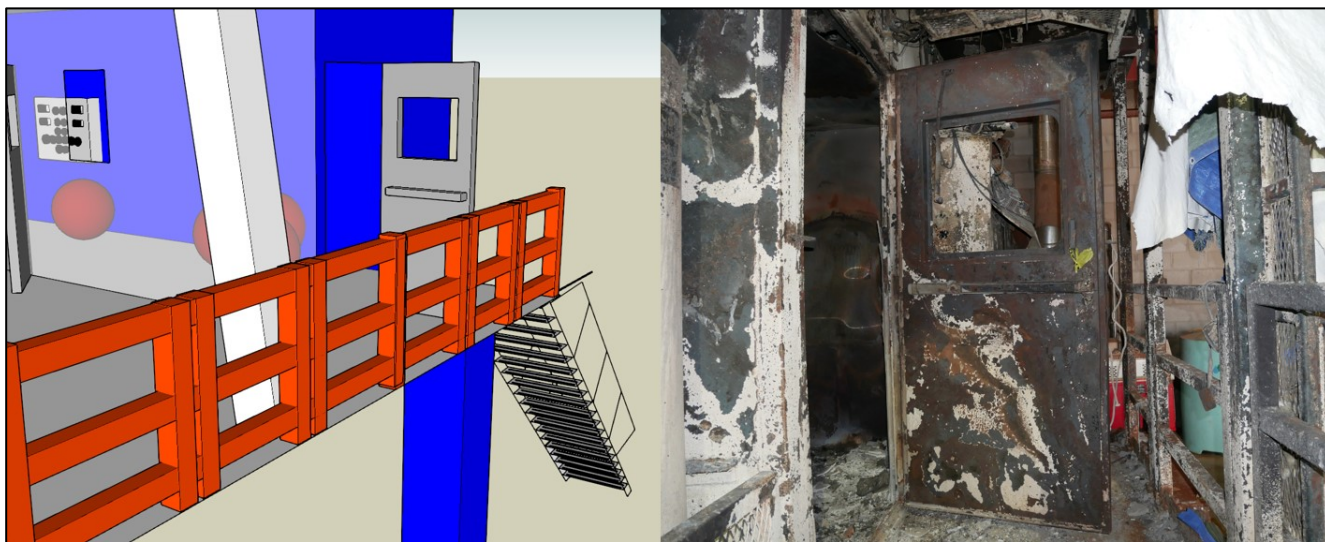
Figure 46. The most viable exit door was hinged such that when the door was opened, the door blocked the escape path to the ground.

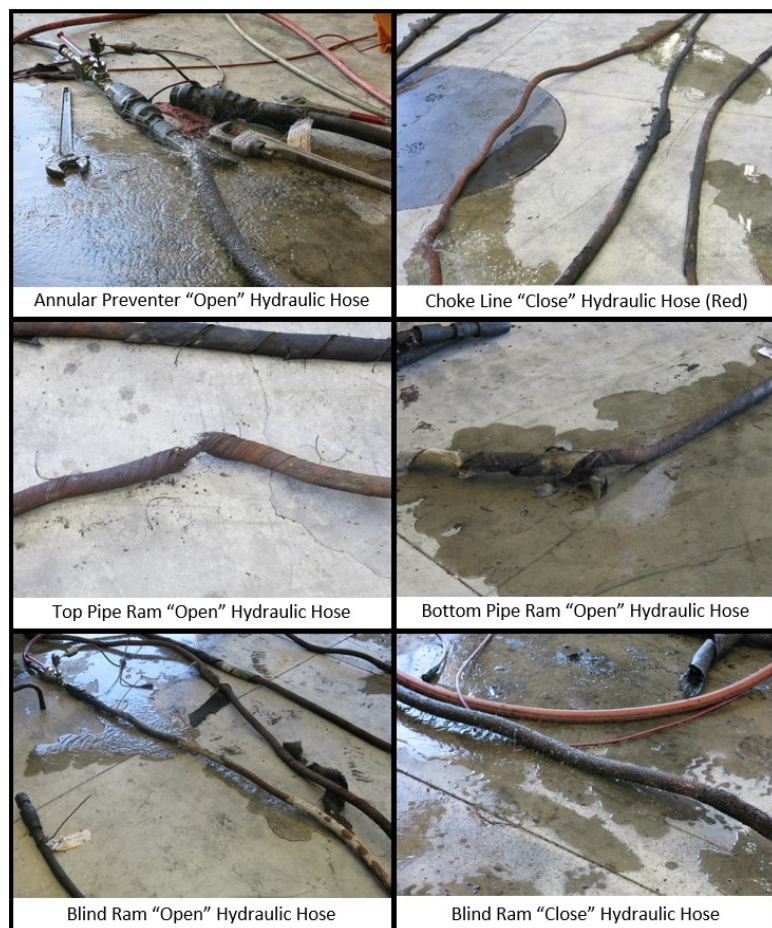
The blowout preventer also failed to close when its activation was attempted after the fire started. The CSB determined the BOP did not function likely because the control hoses that supplied hydraulic fluid to the BOP to function the rams had burned in the fire and leaked the hydraulic control fluid, soon depleting the accumulator stored pressure to the point the blowout preventer could not be closed.

Figure 50. Photos of hydraulic hoses that were installed between the accumulator and BOP, used to send high-pressure hydraulic fluid to the BOP rams to open or close the rams. The hoses were damaged by fire. The hydraulic hoses were leak tested using 40-50 psig water, and all hoses leaked water.

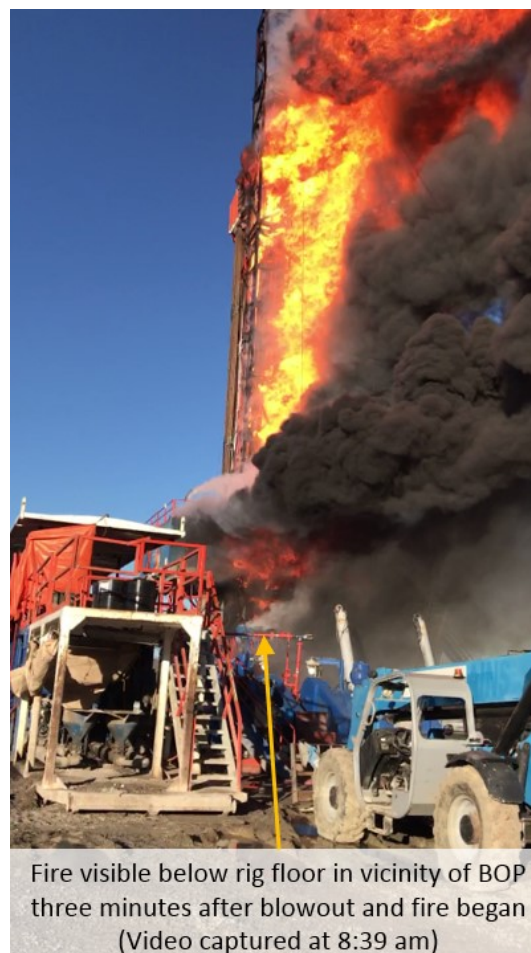
Figure 51. Video still of Patterson Rig 219 fire, taken 3 minutes after blowout began.

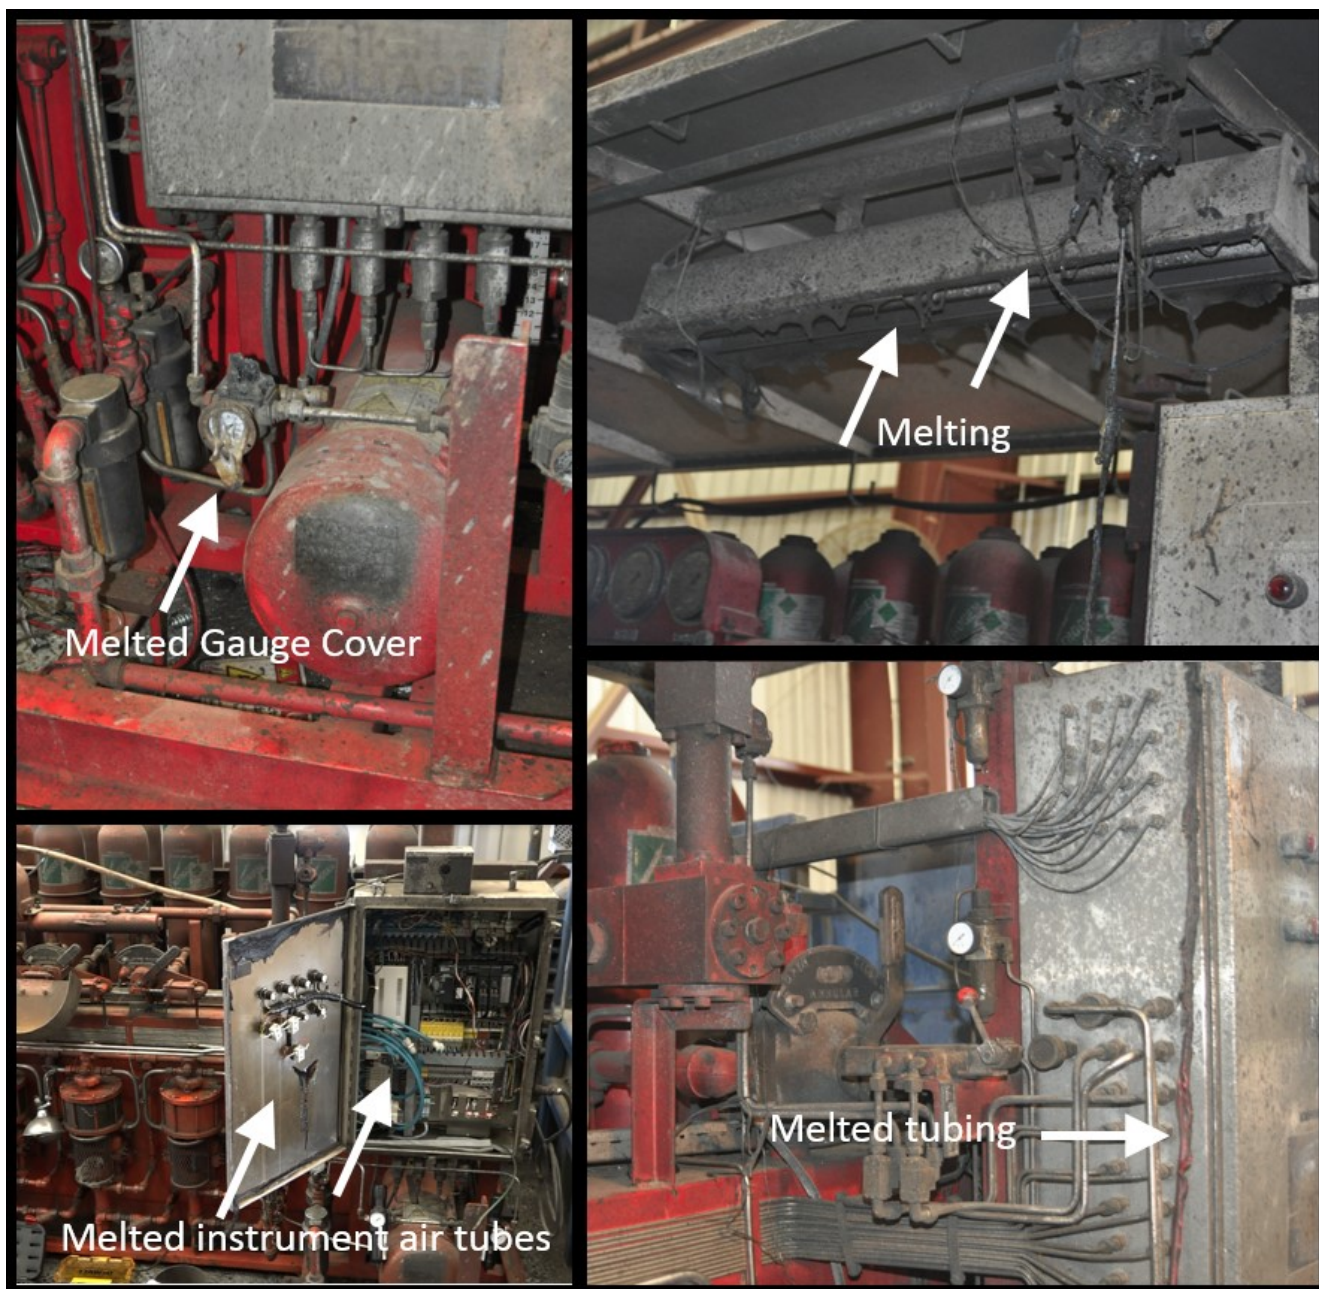
Figure A- 2. Photos of observed heat damage to Patterson Rig 219 accumulator

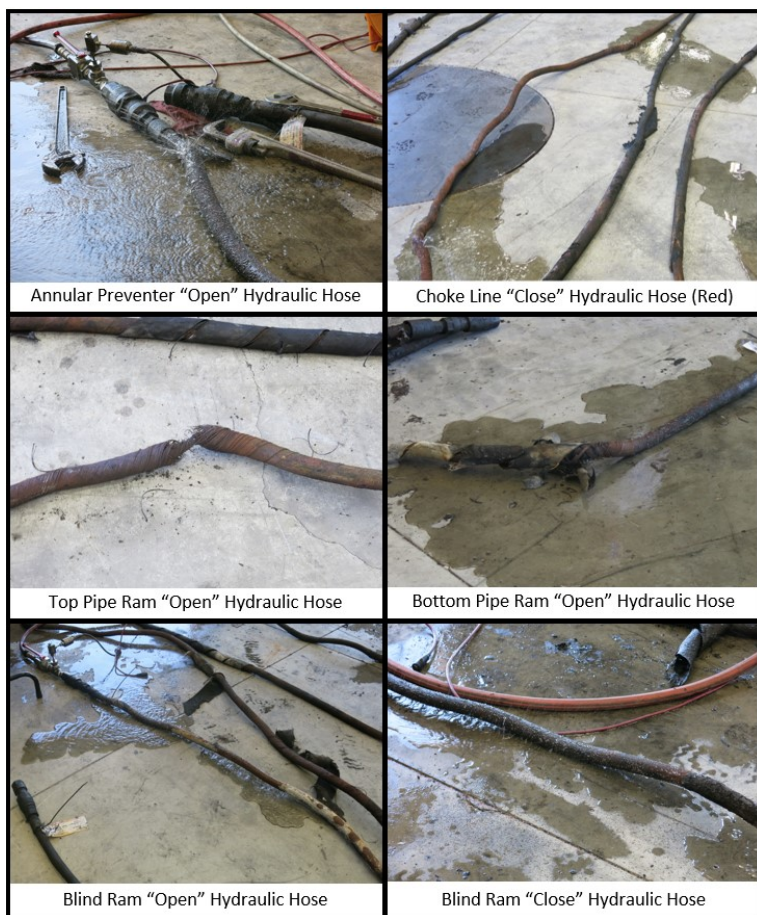
Figure A- 5. Photos of hydraulic hoses that were installed between the accumulator and BOP, used to send high-pressure hydraulic fluid to the BOP rams to open or close the rams. The hoses were damaged by the fire. The hydraulic hoses were leak tested using 40-50 psig water, and all hoses leaked water.

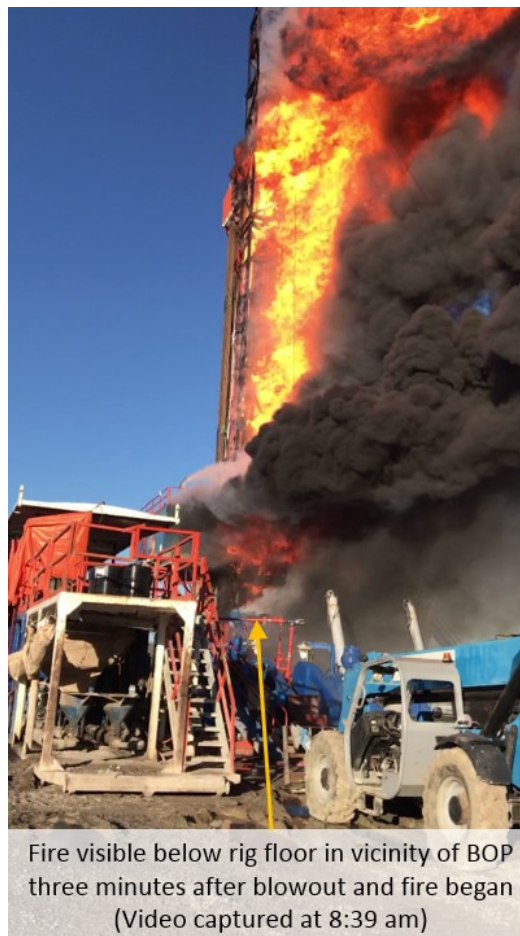
Fire visible below rig floor in vicinity of BOP three minutes after blowout and fire began (Video captured at 8:39 am)
