## Investigation Report

Published: June 12, 2019

On January 22, 2018, a blowout and rig fire occurred at Pryor Trust 0718 gas well number 1H-9, located in Pittsburg County, Oklahoma. The fire killed five workers, who were inside the driller's cabin on the rig floor. They died from thermal burn injuries and smoke and soot inhalation. The blowout occurred about three-and-a-half hours after removing drill pipe ("tripping") out of the well.

# Gas Well Blowout and Fire at Pryor Trust Well 1H-9

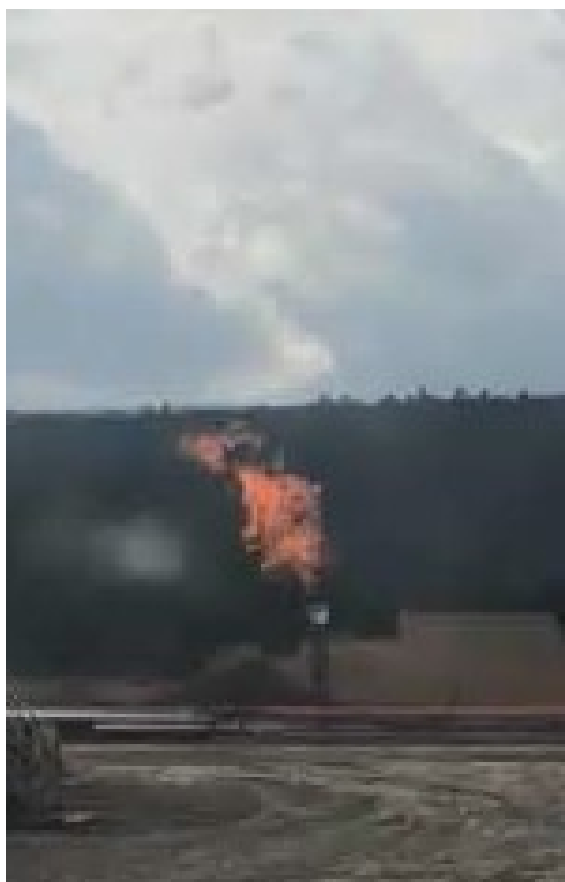
<sup>f</sup> The CSB considered whether the flare might have been produced by “drilled gas,” which is gas contained in the drilled rock cuttings. The CSB concluded that the flare likely was not produced by drilled gas because during the two-and-a-half bottoms up circulations, most, if not all, drilled gas would be circulated out of the well. The flaring at 6:21 pm indicates the well was likely underbalanced.

Figure 9. Video still of flare at 11:10 am on January 21, 2018.

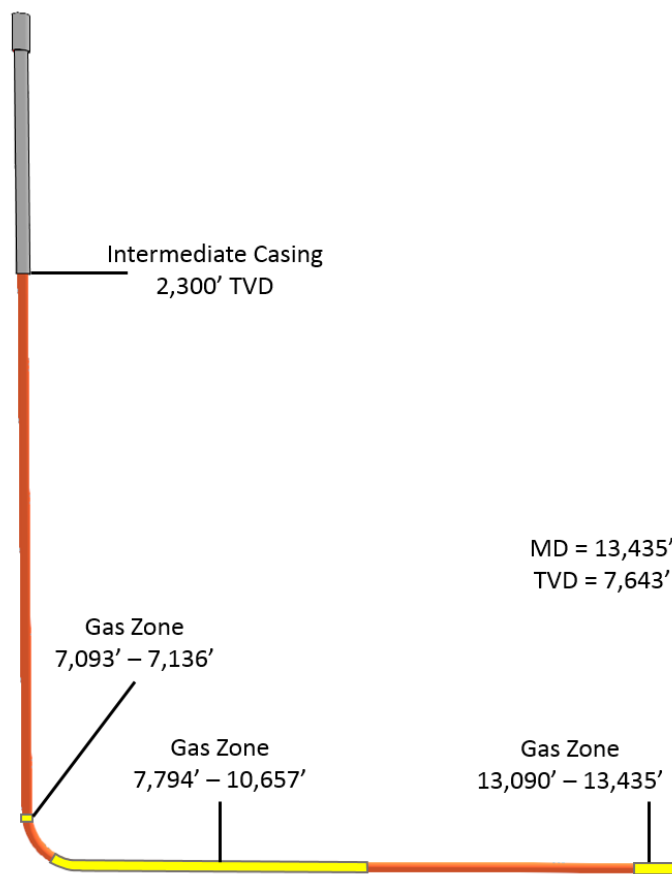
The well profile at this point is shown in Figure 10. Post-incident analysis of the well data shows that the 11,000 feet of uncased, open wellbore included three areas where some amount of gas had entered the well while drilling, as interpreted from measured gas units during the drilling operation and the flaring at the surface that occurred on January 21.

Figure 10. Areas where gas entered the wellbore while drilling.

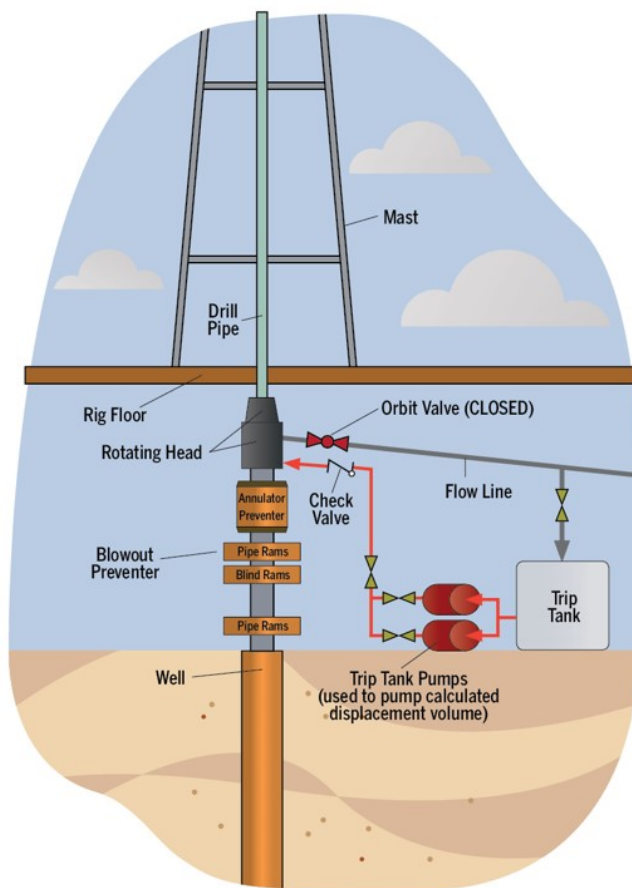
The Calculated Fill tripping method involved stopping all mud flow from the well by closing the **flow line isolation valve** (commonly called the **orbit valve** by Patterson, the drilling engineer, and the company man) with the pressure-containing **rotating head** installed. The plan was then to periodically pump a calculated volume of mud into the well with the intent to replace the calculated volume of the drill pipe removed by turning on and off the trip tank pumps (Figure 12). For example, for five drill pipe stands removed, the driller would need to pump 3.2 **barrels** of mud into the well to replace the drill pipe. The drilling engineer communicated to the CSB that, using this method, there was extra protection against gas influx into the well by, if needed, allowing surface pressure to build against the closed orbit valve and rotating head. The thinking was that if the well did flow, there would be no outlet for the mud, so this would keep the well contained.

Discussed below, by the time the drill bit reached the top of the curve, 20 barrels of mud less than the calculated drill pipe displacement volume had been pumped into the well. While the well appeared to be filled to the surface, the volume discrepancy is an indication that gas had entered the well, occupying this 20-barrel portion of the drill pipe displacement volume (Sections 5.1.2.1 and 5.1.2.2). The company man and drilling engineer were aware the well did not take proper fill, but the full extent of the discrepancy might not have been known because the driller had difficulties with the electronic trip sheet used to track the calculated drill pipe displacement against measured fill volumes during the tripping operation (Section 6.3).

Figure 12. Equipment configuration during Calculated Fill tripping method

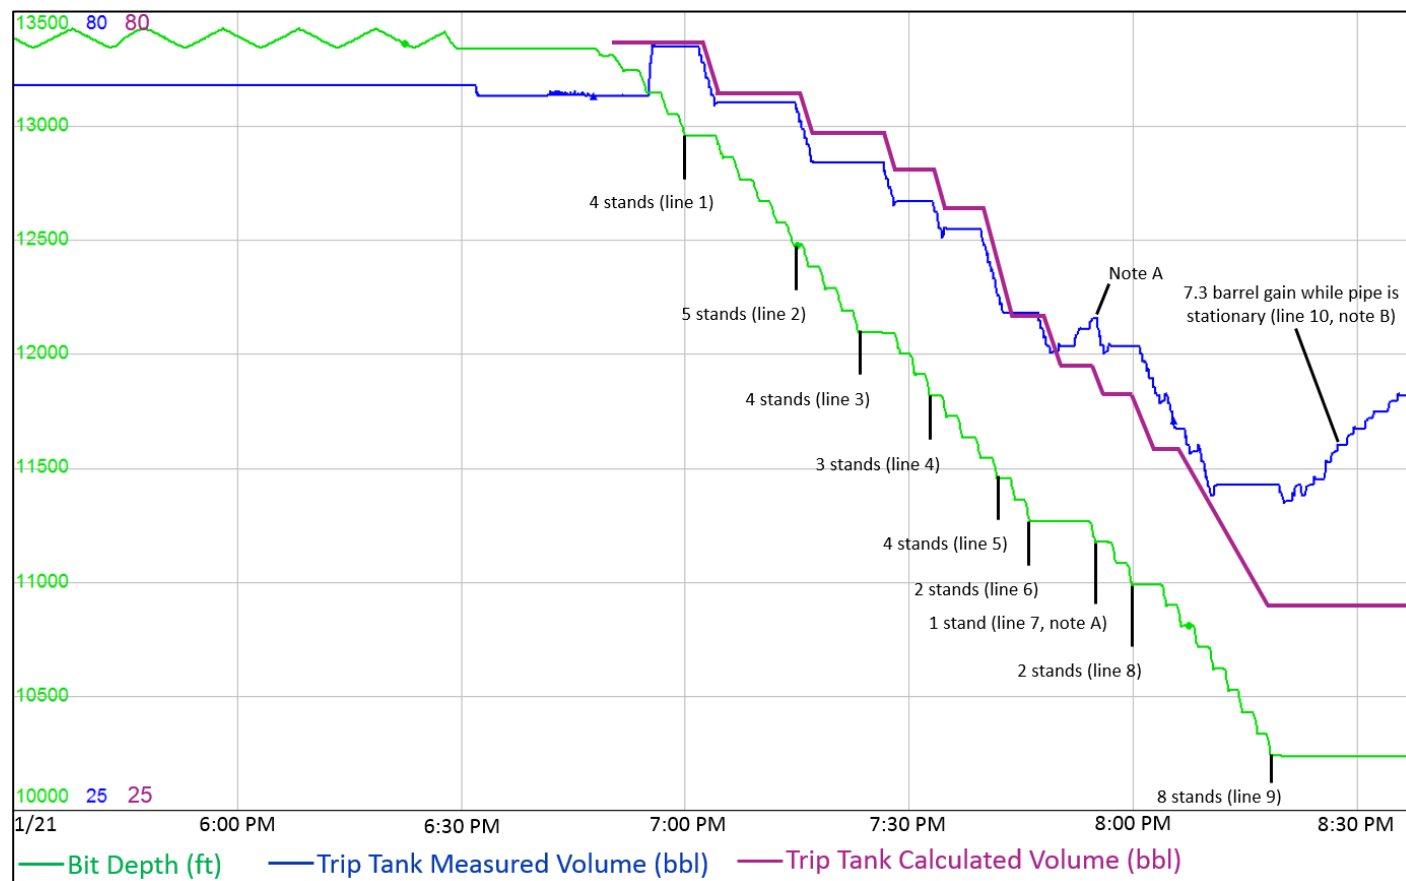
By the time the drill bit reached 10,237 feet MD in the horizontal section of the well, there were 14.3 barrels less mud in the well than needed to replace the volume of drill pipe removed. This volume had evidently been replaced by the equivalent volume of gas entering the well.

Figure 13. Rig data during the trip out of the wellbore from 13,337 feet to 10,237 feet. The blue line shows the actual, measured trip tank volume, and the purple line shows what the trip tank volume would be had a mud volume equal to the calculated volume of the drill pipe removed been pumped into the well. The line numbers and notes indicated in parentheses correspond to the line numbers and notes in Table 1 below.

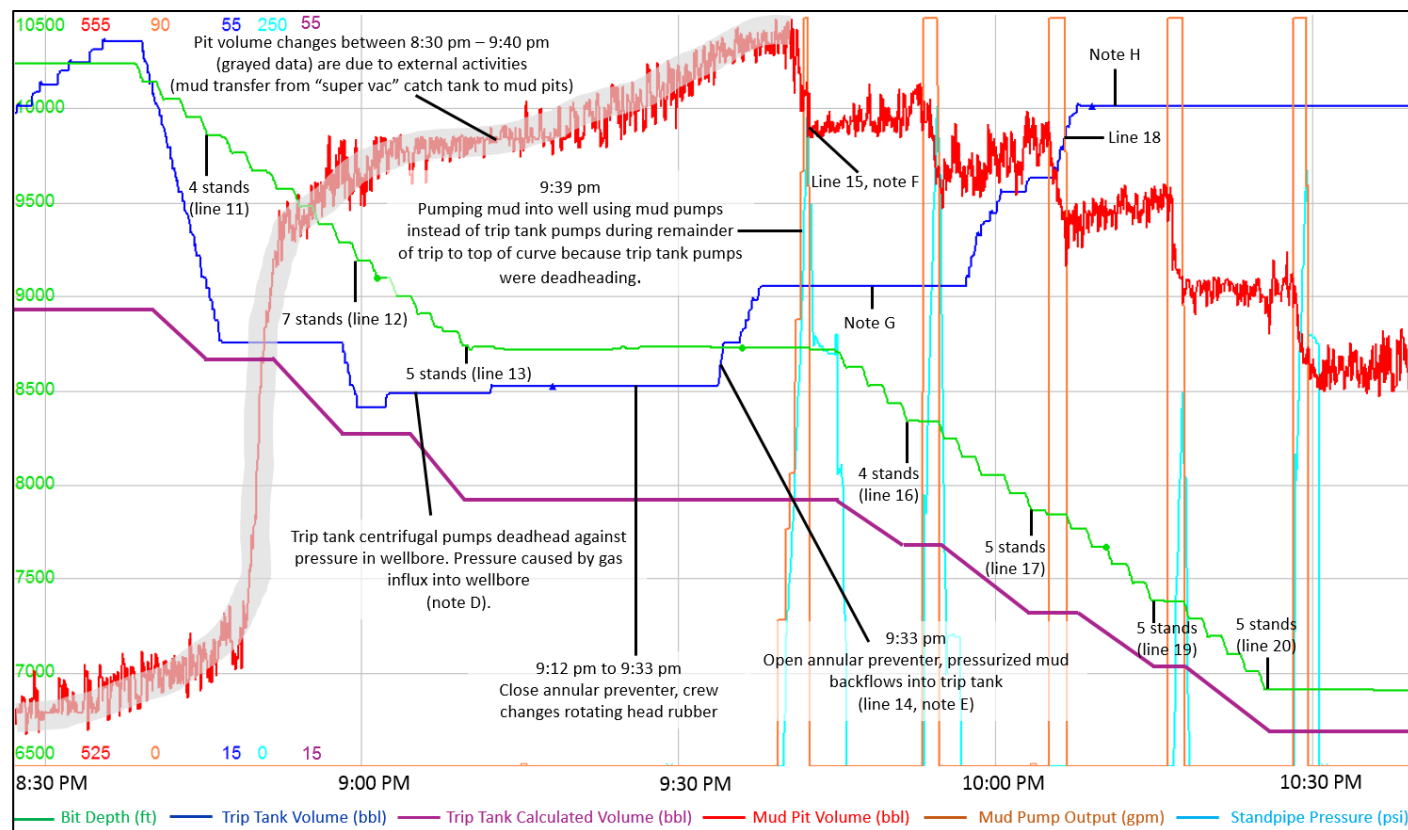
Figure 15 and Table 2 show the rig data and explain the operations during this portion of the tripping operation. By the time the drill bit reached the top of the curve, 20 barrels fewer than the calculated drill pipe displacement volume had been pumped into the well since the beginning of the tripping operation and had evidently been replaced by gas.

Figure 15. Rig data during the trip out of the wellbore from 10,237 feet to 6,905 feet. The blue line shows the actual, measured trip tank volume, and the purple line shows what the trip tank volume would have been had the calculated drill pipe volume been pumped into the well. The line numbers and notes indicated in parentheses correspond to the line numbers and notes in Table 2 below.

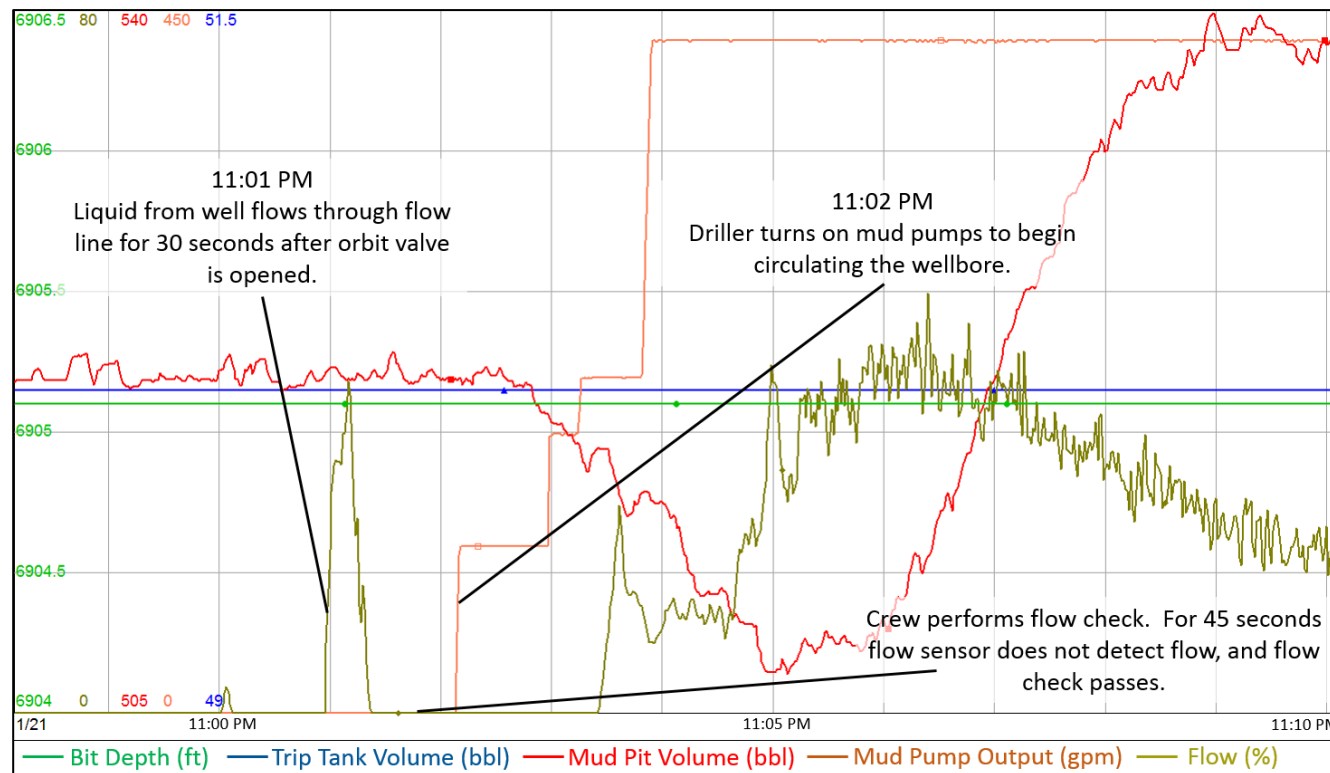
Before beginning circulation, with the mud pumps off, the driller opened the orbit valve to perform a flow check. The rig data shows that a small amount of fluid flowed through the flow line, then stopped. The flow check was conducted for 45 seconds. With no flow observed, the flow check was considered to have passed (Figure 18).

The CSB identified the following hypothesis that may explain the no-flow condition at the surface: A gas bubble might have been at the surface of the well when the driller opened the orbit valve at 11:01 pm. This gas bubble might have escaped from the well when the orbit valve was opened, causing the mud volume at the surface to drop below the flow

return line (Figure 17). The height of mud in the well might have been increasing during this flow check, but not to the point of reaching the flow line. This hypothesis is supported by the 80-second delay between when the mud pumps were turned on and when mud began flowing through the flow line (Figure 18).

Figure 18. Rig data when the drill bit reached the top of curve. Crew performed a flow check at top of curve. No flow was observed for 45 seconds. Driller turned on pumps to circulate the well.

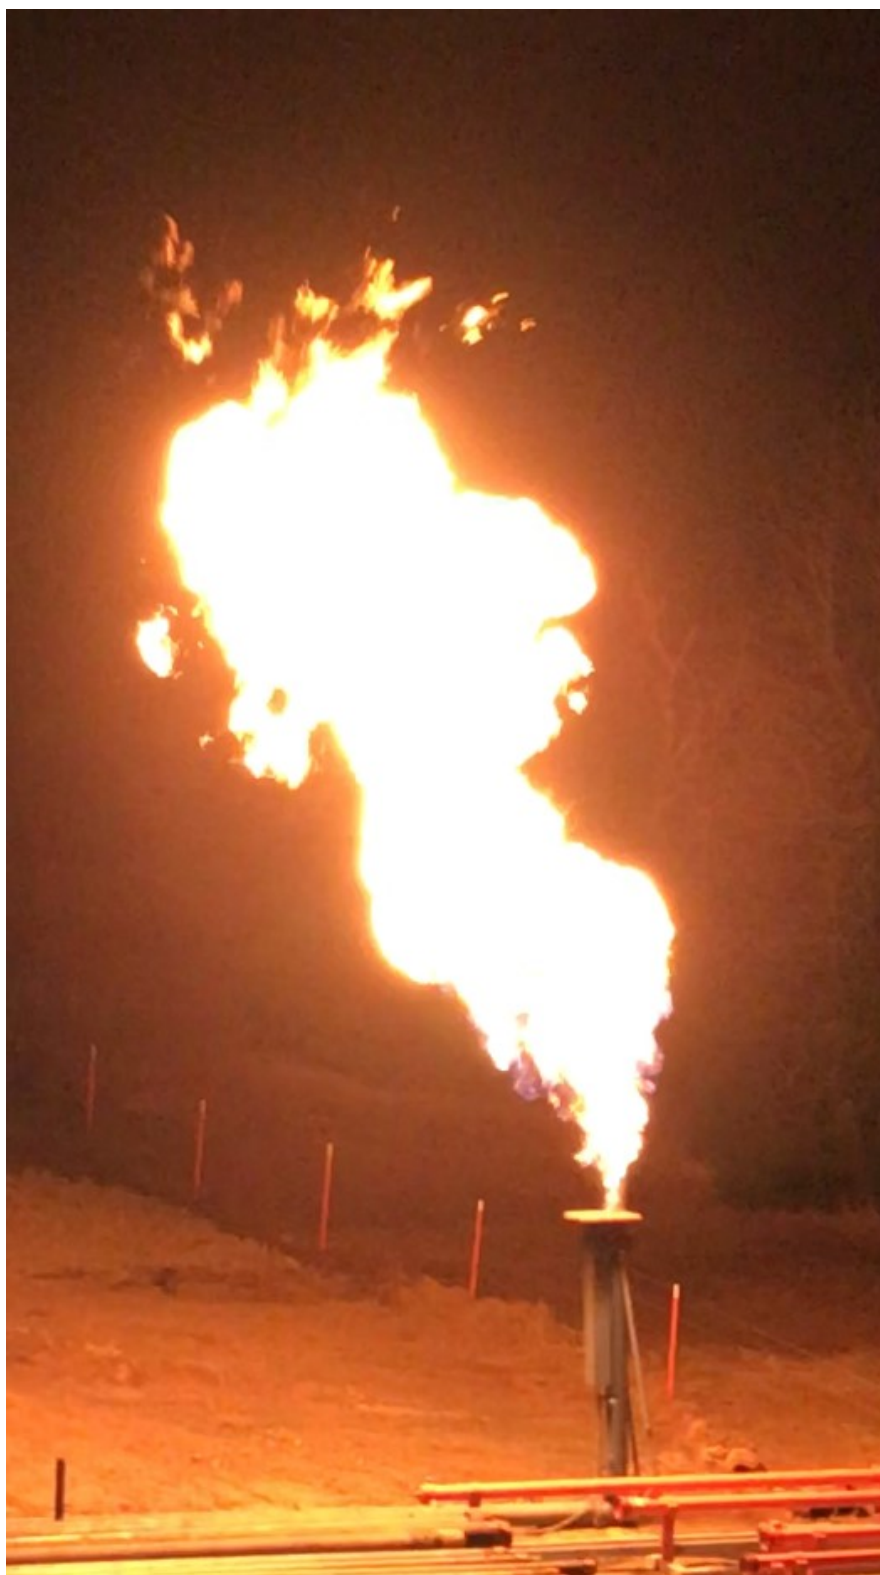
Accepting the indications of a successful flow check, the driller ramped up the mud pumps at 11:02 pm and proceeded with circulating the well by pumping mud down through the drill string with the mud returning to the surface and flowing through the flow line. The crew remembered the flare activating during this activity (Figure 19), indicating gas was coming out of the mud returning at the surface, and then going out at 6,700 strokes of the positive displacement mud pumps (11:57 pm)<sup>a</sup> (Figure 20). Appendix F shows a comparison of Figure 20 with a circulation operation performed days earlier, illustrating the difference in the appearance of the data. While circulating, the slug that had been pumped into the drill pipe at about 6:30 pm before tripping exited the drill pipe and entered into the annulus, adding additional pressure to the well until the slug was circulated out of the annulus during the operation.

*Figure 19. Image of flare from video captured at 11:06 pm on January 21, 2018.*

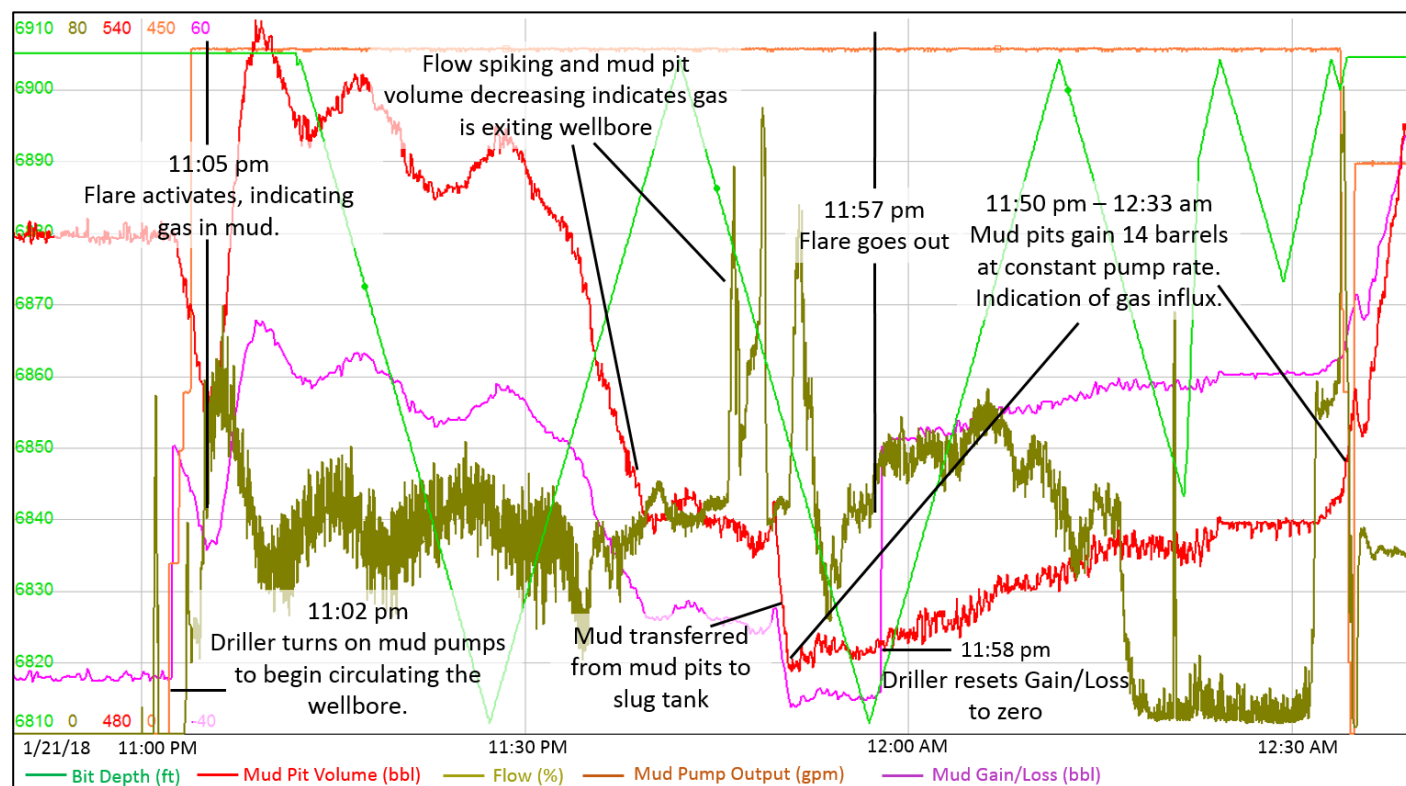
Figure 20. Rig data while circulating the wellbore at the top of the curve. The flare activated while circulating, indicating gas in the mud. Between 11:50 pm and 12:33 am, the mud pits gained 14 barrels while the mud pumps were circulating at a constant pump rate. This pit gain indicates there was gas in the well.

The driller told the CSB he observed full returns, no losses and no gains, while circulating the well. Post-incident review of the well data, however, indicates that while circulating, the mud pits were gaining mud, indicating gas was in the well; between 11:50 pm and 12:33 am, the mud pits gained about 14 barrels (Figure 20).<sup>a</sup>

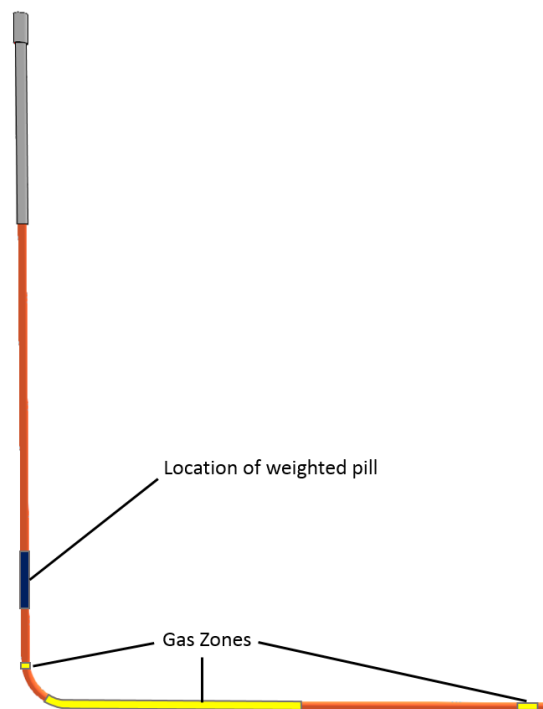
At 12:35 am, the drilling crew pumped 46 barrels of the pill into the drill pipe. Following the pill with mud, they pumped the pill out of the bottom of the drill pipe and into the annulus with the bottom of the pill at a depth of about 6,500 feet, and with the top of the pill at about 5,800 feet (Figure 21). Some of the pill material remained in the bottom of the drill pipe.

Figure 21. Depiction of well with gas zones and location of weighted pill.

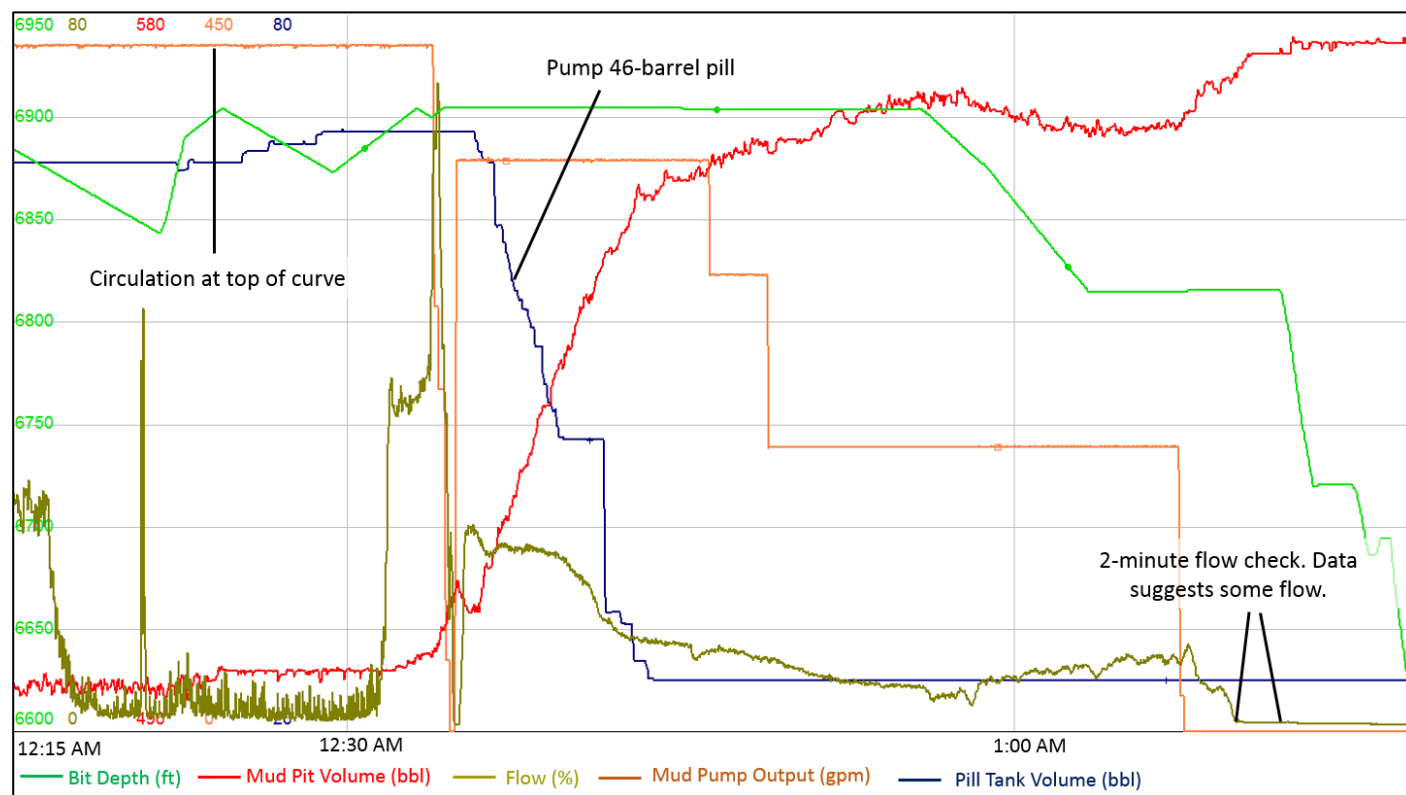
After spotting the pill, at about 1:10 am the crew performed a visual, 2-minute flow check. The flow check passed. However, the CSB could not verify that the crew observed no flow during this flow check. The return flow meter data indicates some very small flow (1% of the flowmeter scale) during this flow check (Figure 22). Despite the flow check result, gas was still entering or expanding in the well. The 50-barrel volume and 10-pound-per-gallon weighted pill did not produce the hydrostatic pressure necessary to prevent gas from entering the vertical portion of the well. After pumping the weighted pill, the well was still underbalanced and the primary well control barrier was still not in place (Section 6.5).

Figure 22. Data during pumping of pill and subsequent flow check.

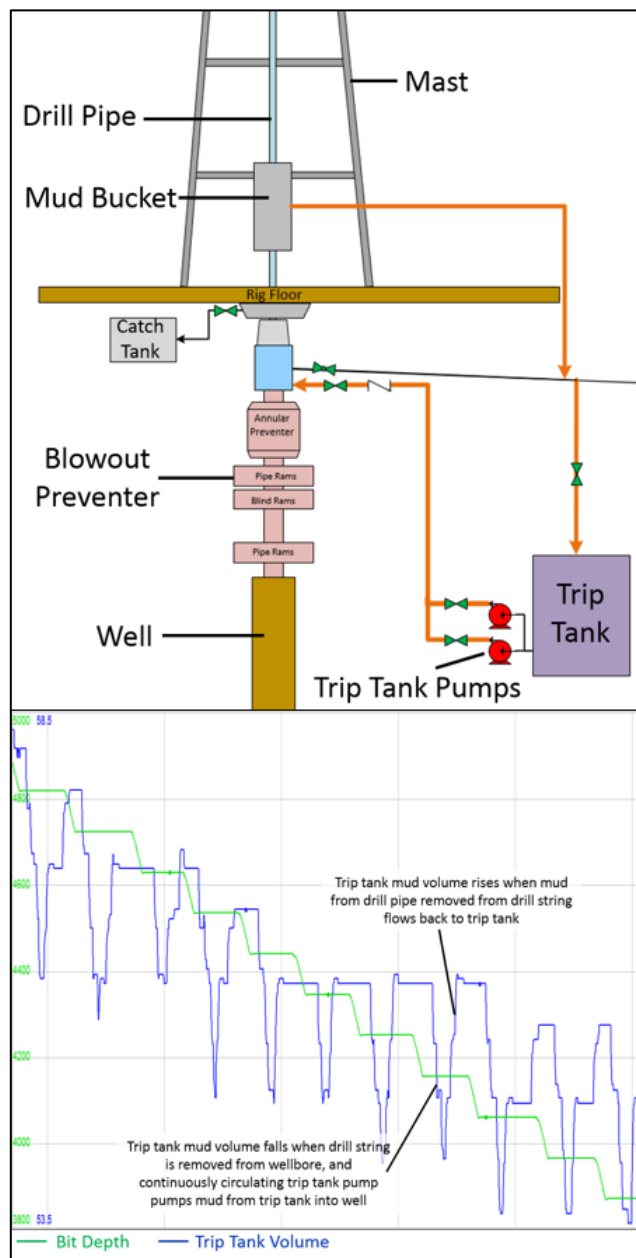
On Rig 219, the mud bucket discharge was routed to the trip tank. Level changes in the trip tank are a key indicator of mud gains or losses while tripping, and adding the mud into the trip tank from the mud bucket during the tripping operation confounded that information for the driller and company man. As the crew tripped out pipe, the trip tank volume fluctuated up and down from mud draining into the trip tank and from mud being pumped out of the trip tank (Figure 24). The driller communicated that he had never before tripped wet pipe out of the well with this lineup, and all of the volume fluctuations in the data made monitoring for the correct volume reduction in the trip tank difficult.

*Figure 24. Rig equipment alignment and data during tripping operation out of vertical portion of well. The crew was tripping wet pipe, and the mud from the pipe stands removed drained back to the trip tank, causing the trip tank volume to fluctuate.*

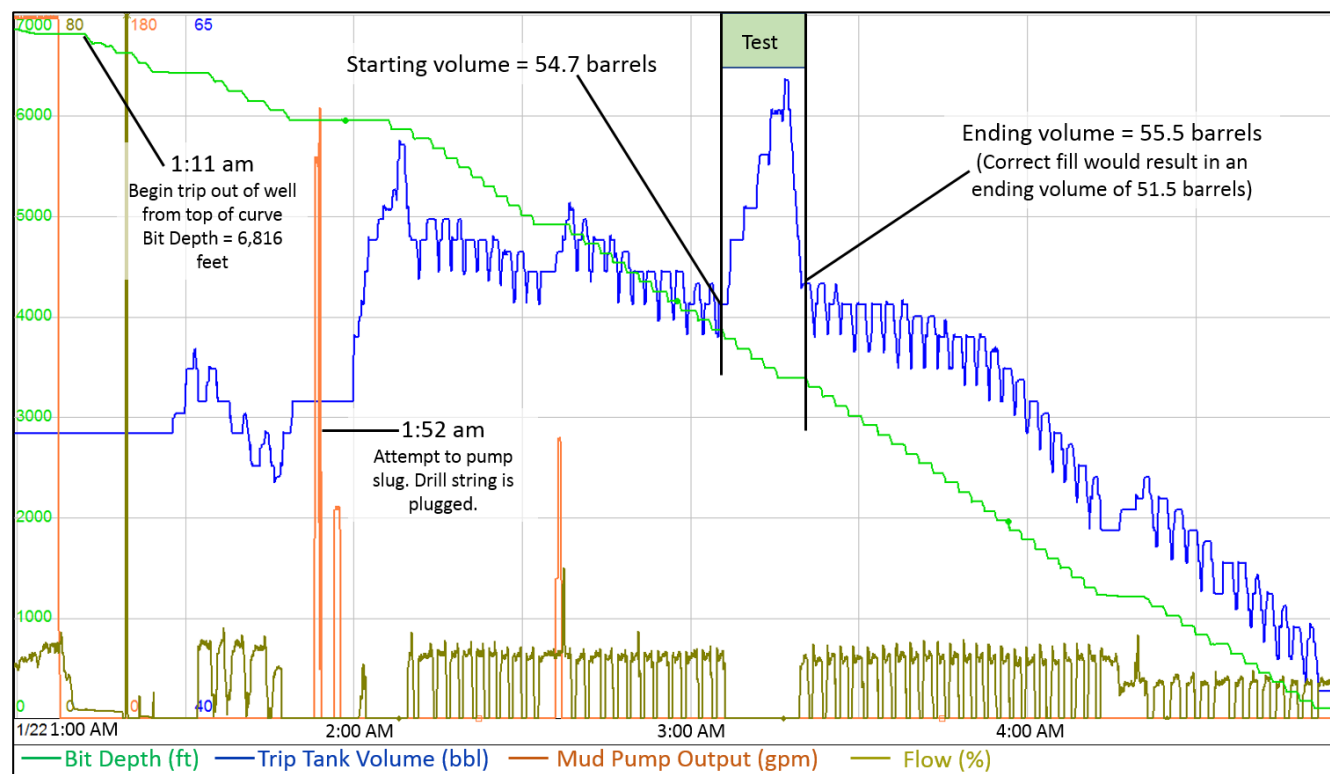
During the tripping operation, the driller and company man performed a test to determine if the well was taking proper fill. The company man wanted to double check that dry pipe volume was the correct displacement volume for their trip sheet calculations (Figure 25). They turned off the trip tank centrifugal pumps and removed five stands of drill pipe from the wellbore. They then turned on the trip tank centrifugal pumps to see if a corresponding five drill-pipe-stand volume of mud pumped into the well. The driller and company man believed they saw the proper volume of mud enter the well, and they resumed tripping normally. A review of the data, however, shows that the full calculated volume for five stands of drill pipe did not enter the well. From start to end of test, the trip tank volume should have reduced by 3.2 barrels, the volume required to replace the five stands of pipe. By the end of the test, however, the trip tank volume had actually increased by 0.8 barrels, indicating that the well did not take any fill, and in fact had gained four barrels of influx or expanded gas. It is unclear why the driller and the company man believed this test passed. The result was that, unknown to Patterson and RMO, gas continued to enter or expand inside the well during the tripping operation. By the end of the trip, less than half of the drill pipe volume removed from the well had been replaced with mud.<sup>a</sup> The other half of the drill pipe volume was likely replaced with hydrocarbon gas from the formation(s).

Figure 25. Rig data during trip out of vertical portion of the well on January 22, 2018. The driller and company man were confused by the trip tank volume fluctuations and about what pipe volume to use in trip sheet calculations. The company man and driller incorrectly concluded that the test they performed to determine if the well was taking proper fill had passed.

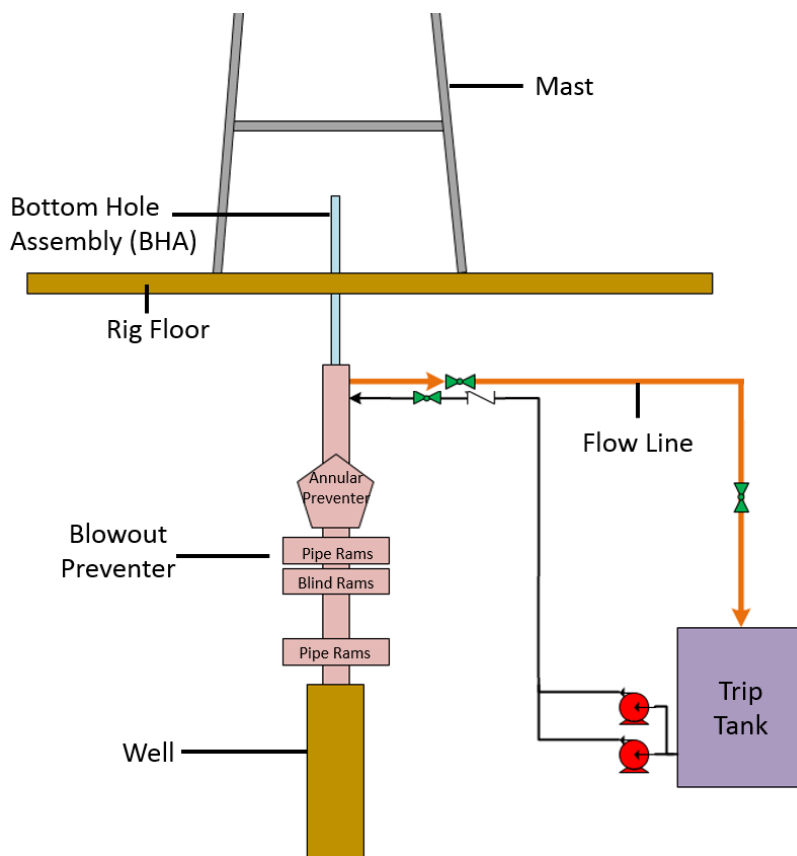
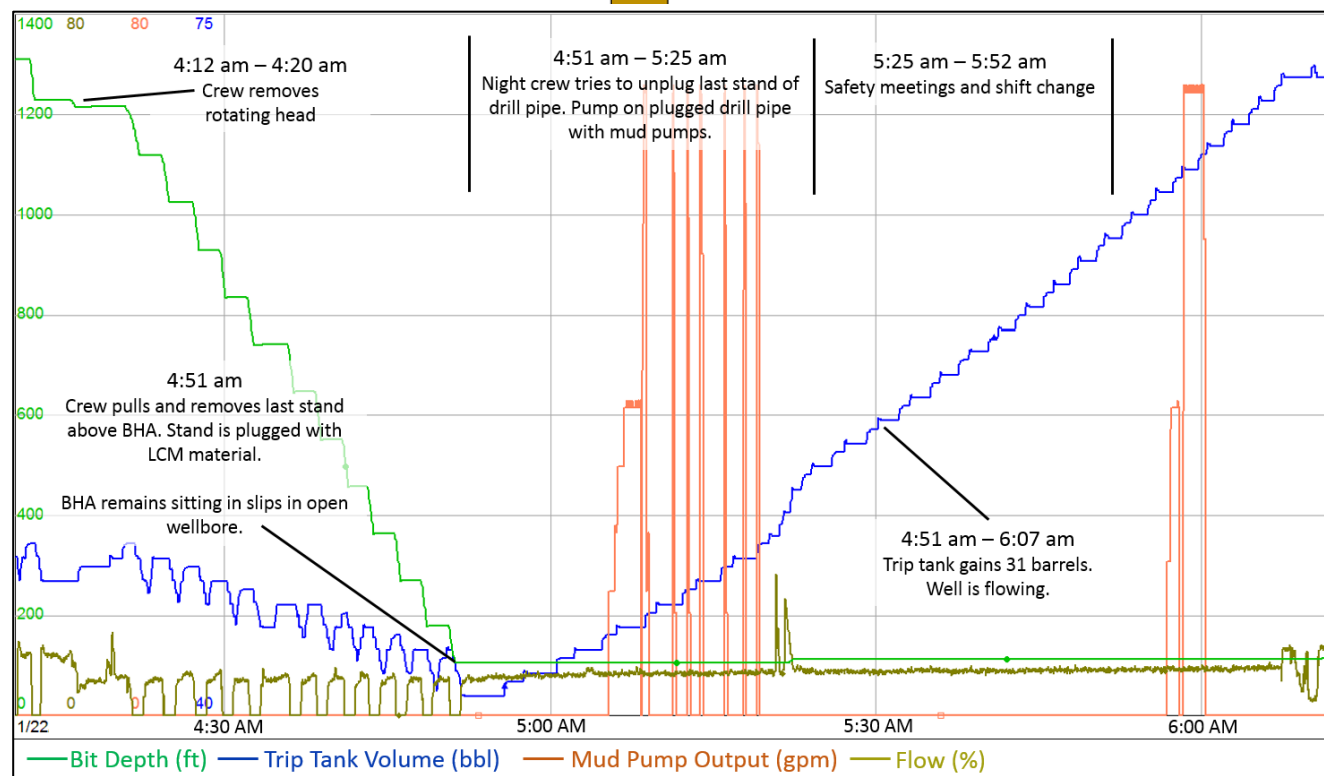
Between 4:51 am and 6:07 am, while the crew was trying to unplug the stand of drill pipe and during shift change, the trip tank gained 31 barrels of mud (Figure 26). The well was flowing because gas was in the well. No one observed this gain in the trip tank, and no one realized the well was flowing.

Figure 26. Rig equipment lineup and rig data between 4:10 am and 6:12 am. Between 4:51 am and 6:07 am, the trip tank gained 31 barrels of mud.

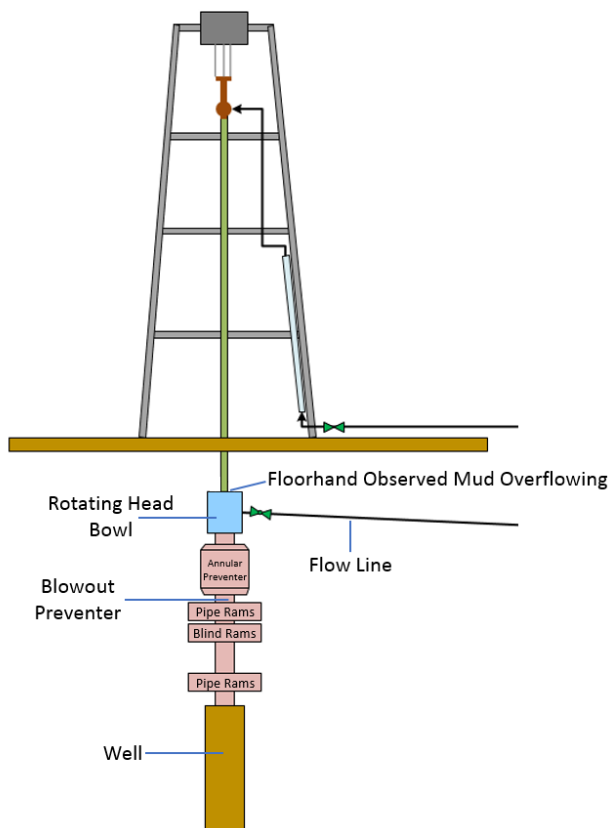
The driller lowered the BHA into the well, until only about 2-3 feet of it remained above the rig floor. At 8:09 am, with the piping now aligned so that flow from the well was routed to the mud pits, the driller reset the mud Gain/Loss indicator on his rig data monitor to zero. He then turned on the pumps to test the BHA tool. A floorhand observed—and told the driller—that when the pumps turned on, mud was coming up out of the top of the rotating head bowl (Figure 28).<sup>b</sup> A crewmember told the CSB that this was expected because the rotating head rubber was not installed. At some point during the testing, the same floorhand observed that mud had stopped coming over the rotating head bowl. He communicated his observation to the driller.

Figure 28. Depiction of where floorhand observed mud coming out of BOP stack while BHA was being tested.

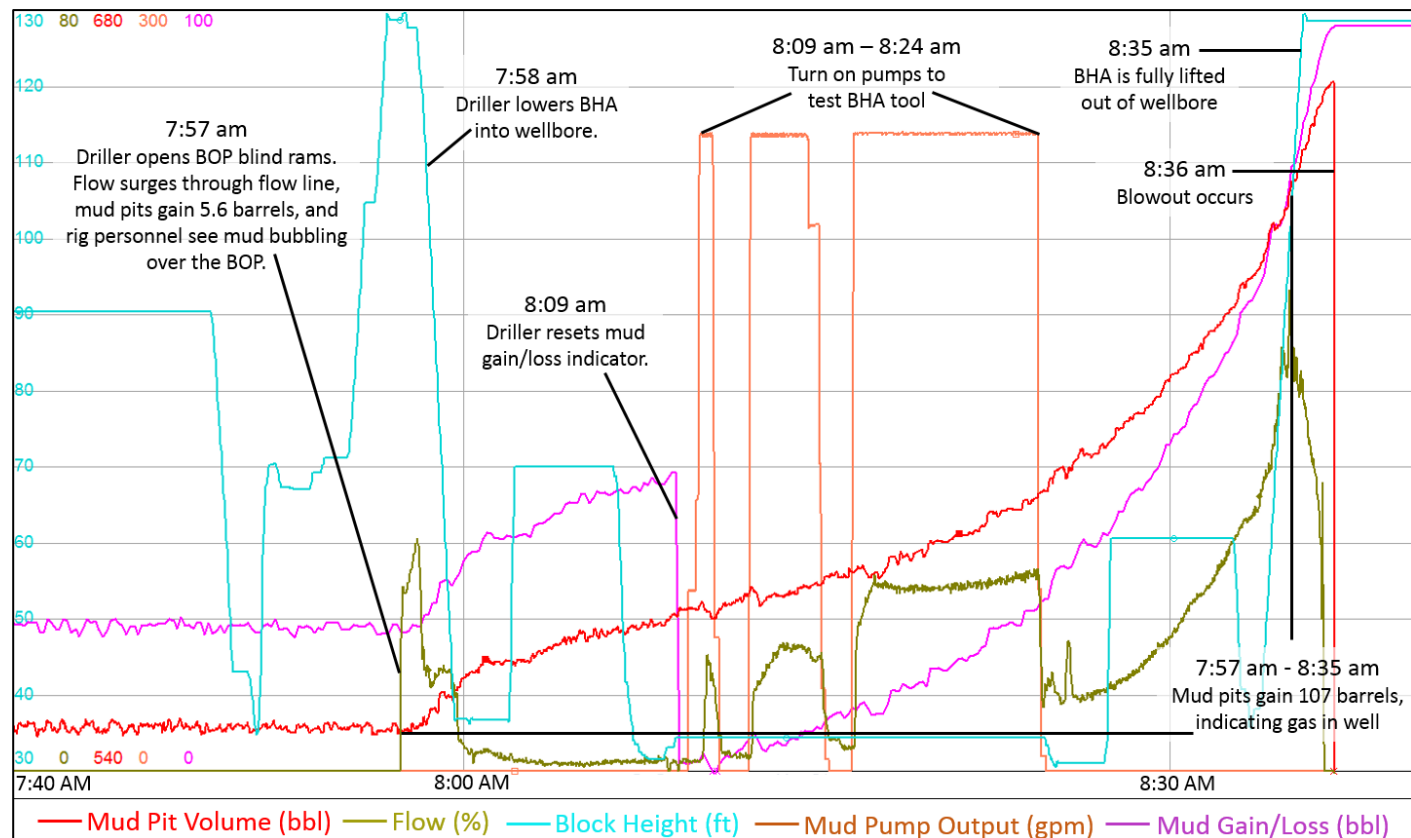
From the time the BOP blind rams were opened at 7:57 am through the completion of BHA testing and removal from well at 8:35 am, the mud pits gained 107 barrels of mud due to gas influx/gas expansion within the well (Figure 29), a

significantly large volume. It is unknown if the driller saw this gain, which would have displayed as a number on a monitor in front of him (Figure 37). No action was taken to shut in the well.

Figure 29. Rig Data between 7:40 am and 8:41 am on Monday January 22, 2018 (day of incident).

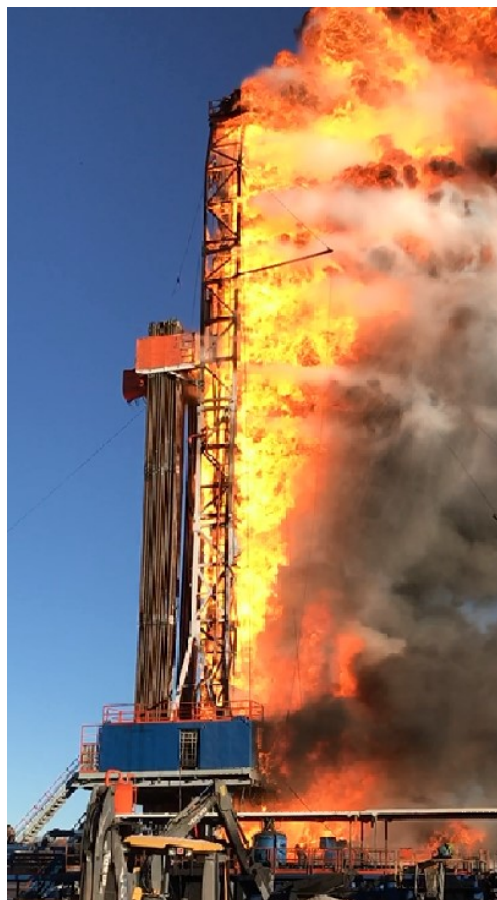
At 8:36 am,<sup>a</sup> shortly after the driller communicated that he was going to close the blind rams, mud started spraying out of the well. The floorhand saw the motorhand and the second floorhand open the door to the driller's cabin so they could run into it from the rig floor. The mud continued to spray out of the well and covered the windows of the driller's cabin. The floorhand moved behind the drill pipe rack on the rig floor with the rig manager. Very quickly after the mud started spraying out of the well, the diesel oil-based mud and gas escaping the well caught on fire (Figure 30).<sup>b</sup> Between the removal of the BHA from the well at 8:35 am and the blowout at 8:36 am, the mud pits gained an additional 12 barrels of mud, totaling to a 119-barrel gain since the blind rams had been opened at 7:57 am.

Figure 30. Video still of the blowout and fire taken shortly after it started.

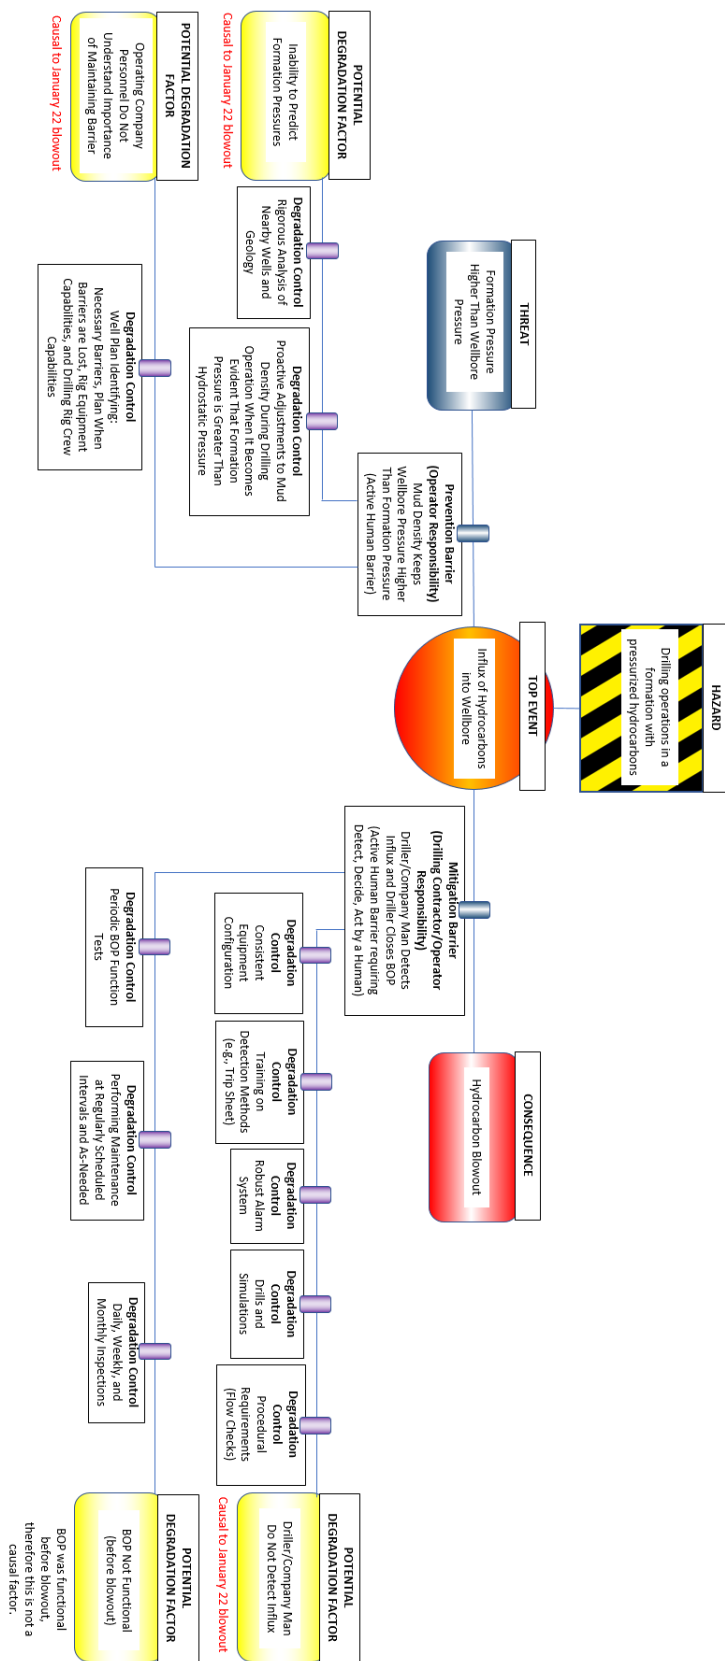
The CSB created a bowtie diagram (Figure 34) to illustrate the two planned barriers to prevent a blowout. Both barriers had associated degradation factors that could, and ultimately did, reduce the reliability and availability of the barriers.

Figure 34. Bowtie diagram of Pryor Trust Well 1H-9 barriers

Like any barrier, the mud barrier was subject to failure. Figure 34 shows two main degradation factors that contributed to the failure of the mud from preventing a gas influx, and no sufficient degradation controls were in place to prevent those degradation factors from leading to failure of the barrier.

Shown in Figure 34, a number of "degradation controls" could have been in place to reduce the likelihood that rig workers would miss the signs of gas influx. These controls include:

An effective alarm system is one of the “degradation controls” shown in Figure 34 to help ensure that the mitigation barrier, the detection of an influx by rig workers and closure of the BOP, would function as expected. In this case, however, shutting down the alarm system nullified it as a degradation control, thereby increasing the likelihood that the detect-influx-and-activate-BOP mitigation barrier would fail, which is what ultimately happened. Had the alarm system been on, the existing alarm system likely also would have nullified the system as a degradation control, since most of the alarms would not have been warning of the ongoing well control event (Appendix E). The alarm system would not have been effective in alerting the driller to the imminent blowout.

Shown in Figure 34, drills are an important control to increase the likelihood that the driller will detect a gas influx. Without drills, the degradation factor that “driller does not detect influx” is a greater risk, increasing the likelihood of failure of the secondary “Driller Detects Influx and Closes BOP” barrier.

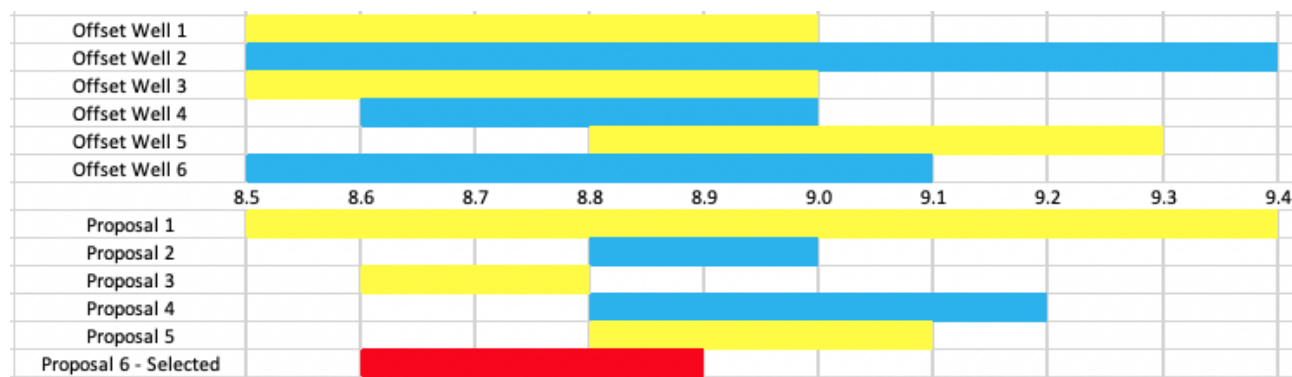
RMO received six different proposals from mud companies for the mud program for Pryor Trust well 2H-16, which were based on the following mud weights for the “production zone” (2,340 ft - 15,929 ft)—the portion of the well where gas was anticipated (Figure 35):

1. 8.5-9.4 ppg
2. 8.8-9.0 ppg
3. 8.6-8.8 ppg
4. 8.8-9.2 ppg
5. 8.8-9.1 ppg
6. 8.6 - 8.9 ppg (Program selected by RMO)

Figure 35. Comparison of the offset well mud weights, and the proposed mud weights provided in the various mud program proposals for the 2H-16 well.

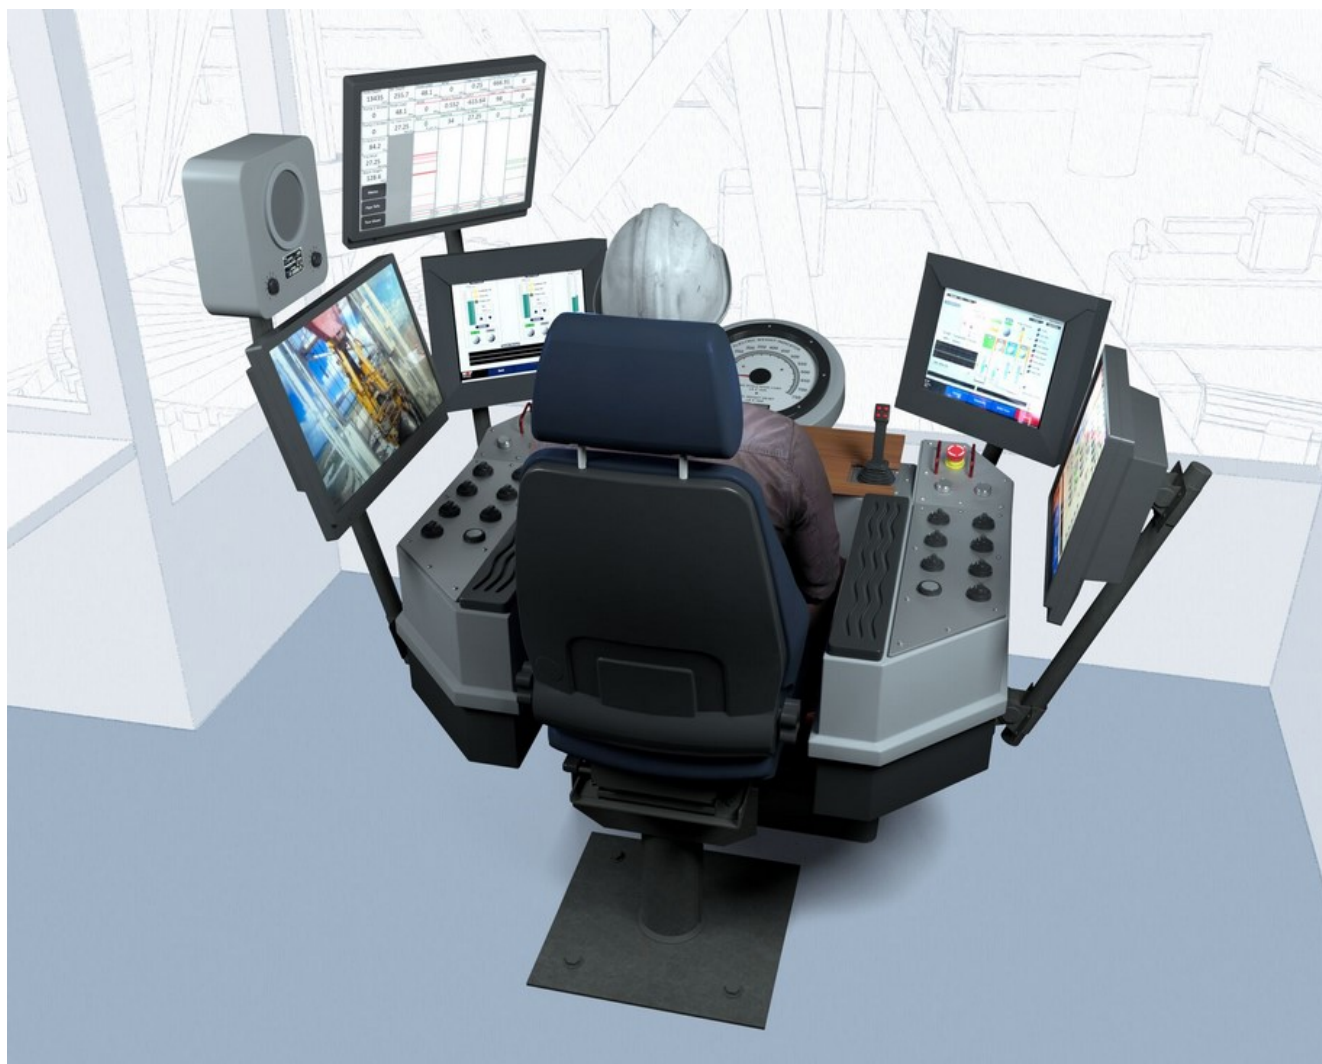
The driller's cabin was equipped with several monitors displaying data and camera footage essential to the drilling operation. A re-creation of the setup is shown in Figure 37. The top screen to the left of the driller displayed an aggregate of the drilling data, including drill bit depth, weight on bit, torque, stroke count, mud pit volumes, trip tank volume, gain/loss, mud return flow, and other parameters. The other monitors in front of the driller displayed data for the drawworks,<sup>a</sup> pump parameters, top drive parameters,<sup>b</sup> and camera feed to watch drill pipe latching operations.

*Figure 37. Depiction of driller console on Rig 219. The upper screen to the left of the driller displayed the aggregate of the drilling data.*
