## Investigation Report

Published: June 12, 2019

On January 22, 2018, a blowout and rig fire occurred at Pryor Trust 0718 gas well number 1H-9, located in Pittsburg County, Oklahoma. The fire killed five workers, who were inside the driller's cabin on the rig floor. They died from thermal burn injuries and smoke and soot inhalation. The blowout occurred about three-and-a-half hours after removing drill pipe ("tripping") out of the well.

# Gas Well Blowout and Fire at Pryor Trust Well 1H-9

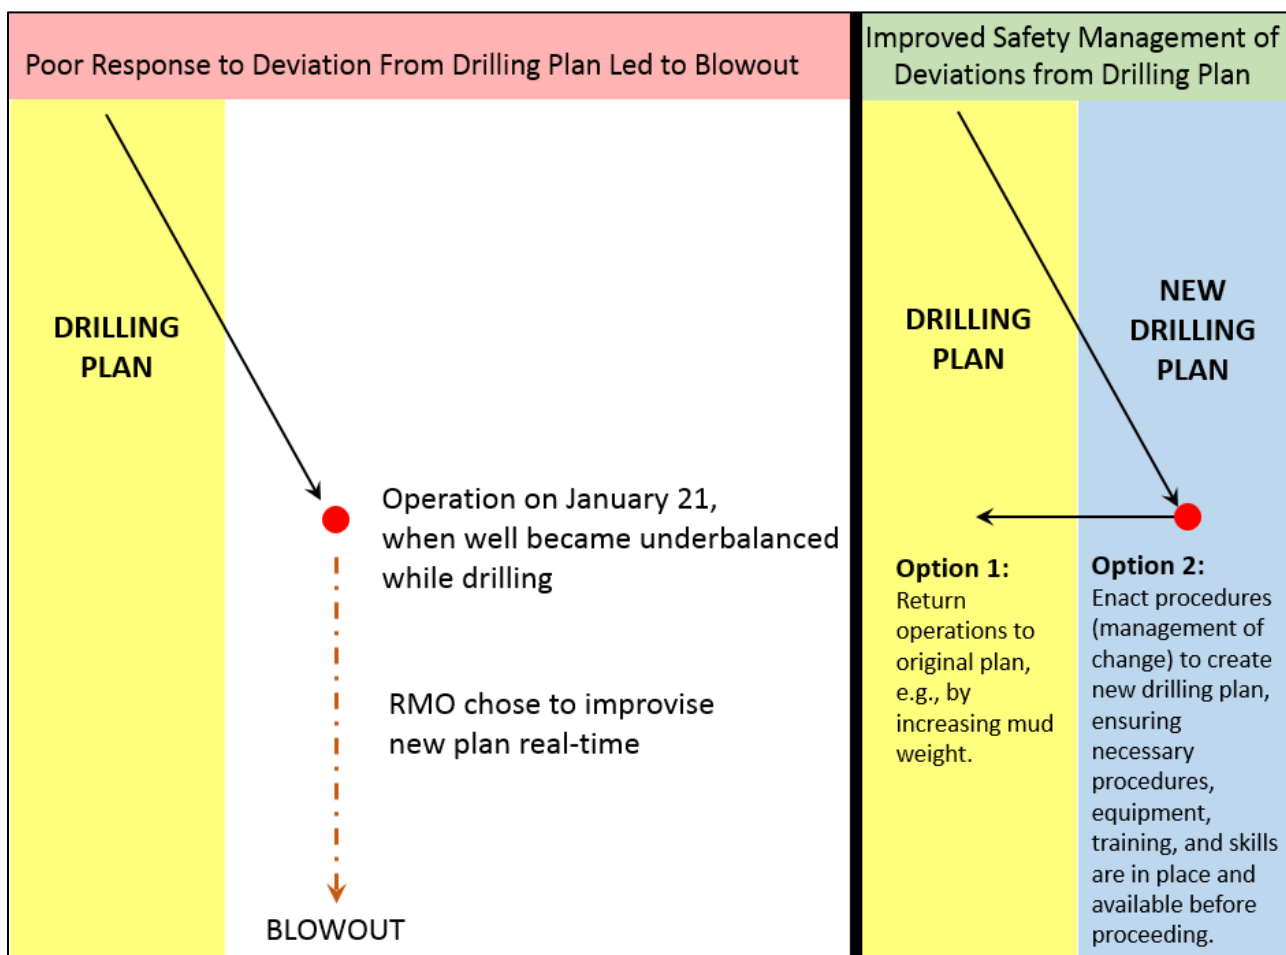
Sometimes operational excursions from original drilling plans are possible due to the inability to accurately predict geological behavior and formation pressures. Figure 39 below shows how RMO and its representatives responded to the deviation from the original drilling plan, which did not include underbalanced drilling. On January 21, when the well suddenly was underbalanced, RMO and its representatives chose to improvise a new plan as they proceeded real-time. This decision led to RMO and its representatives not fully considering the hazards of the operation or considering the need for specialized equipment and procedures.

Figure 39. Depiction of RMO's and its representatives' response to deviation from drilling plan (left), and improved safety management of deviations from drilling plan (right)

In operations with a healthy safety management system, when deviations from the original drilling plan occur, one of two options should be enacted, as shown in Figure 39. One option is to adjust parameters to return to the original drilling plan, which in this case would have required increasing the mud weight to return to overbalanced drilling. The second option is to stop operations and create a new drilling plan—using a management of change process—ensuring that necessary procedures, equipment, training, and skills are available so that the new plan can be performed safely before proceeding.

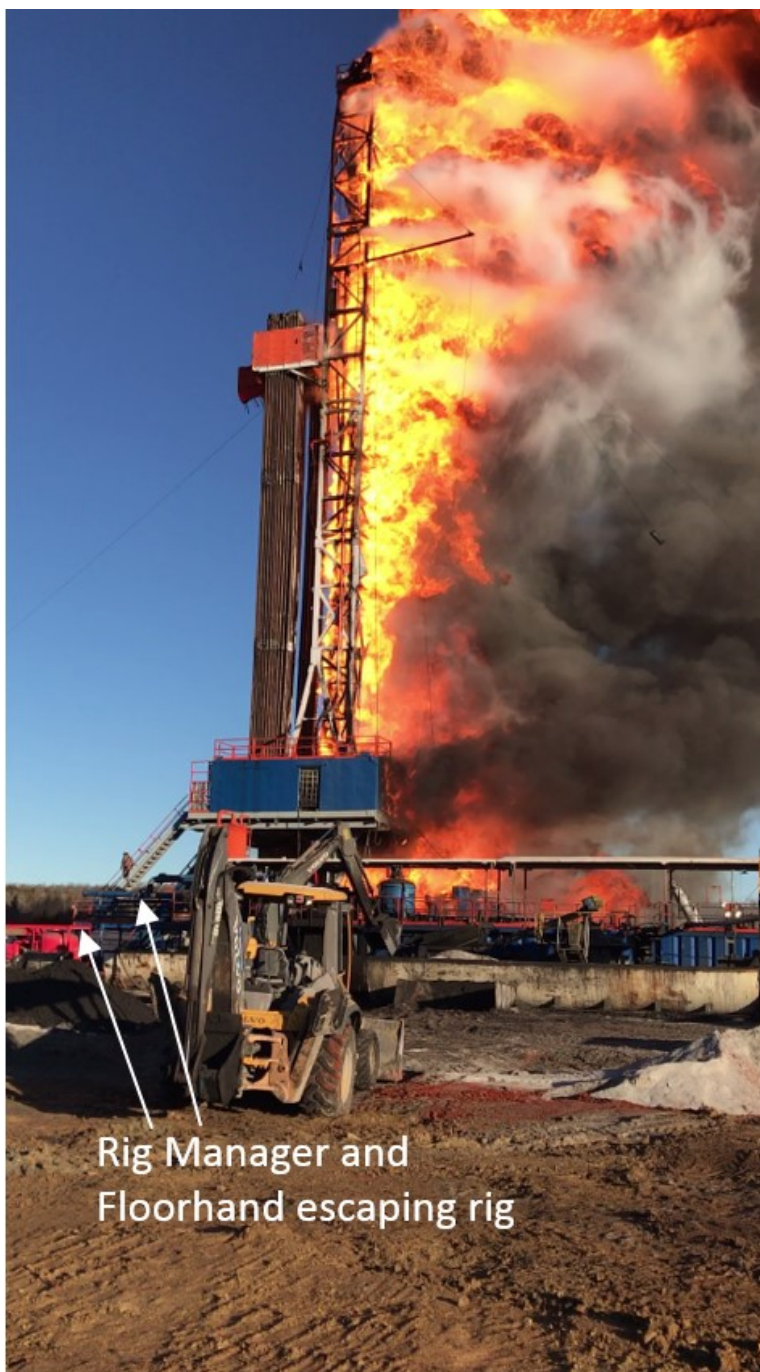
Witness testimony and video taken shortly after the blowout began confirm that the ignition of the gas and mud escaping from the well occurred within seconds after the mud started erupting onto the rig floor. The fire was massive and intense, engulfing much of the rig floor and the driller's cabin (Figure 43). It is unknown how long the victims remained alive inside the driller's cabin, but they had no viable escape routes. There were two exit doors from the driller's cabin, but both of those exit doors were blocked by flames after the gas and mud ignited (Figure 44).

Figure 43. Still from video captured at 8:36 am, shortly after blowout started. The rig manager and floorhand can be seen escaping the rig. At this point, the fire has engulfed the driller's cabin (far side of photo).

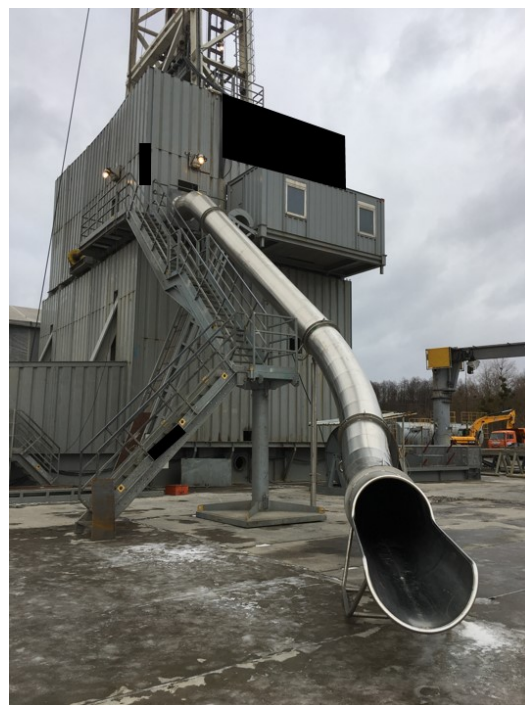
The design and location of the driller's cabin on Rig 219 appears to be typical across the industry. Drilling rig design changes are needed to help protect workers on the rig floor and in the driller's cabin from blowout and fire hazards, and to allow quick escape from the rig. Had the fire rating of the driller's cabin been ensured for a minimum time (e.g., 10 minutes), with emergency escape options from the driller's cabin floor (e.g., an escape hatch) or from the back wall, there could have been a better chance for the workers in the driller's cabin to survive this incident. As an example of a quick evacuation design, the CSB was informed that escape slides are required in Ukraine for the safety of drilling rig workers (Figure 47). This and other escape options would need to be evaluated by the U.S. drilling industry.

*Figure 47. Example design strategy to provide quick egress from drilling rig during a blowout.*

- Protect drilling cabin occupants from blowout hazards including heat, blast overpressure, and projectiles; and
- Establish the minimum required evacuation methods from the drilling cabin, rig floor, and mast in the event of a blowout so personnel can quickly escape in variable hazard location conditions.

The drilling industry should also consider alternative design methods, such as locating the driller's cabin at a safe distance from the well, for example at ground level. Such a design could incorporate the use of cameras to allow the driller to view and direct rig floor activities, keeping workers in the driller's cabin out of range of fire and explosion hazards. [**Recommendation 2018-01-I-OK-R5**]

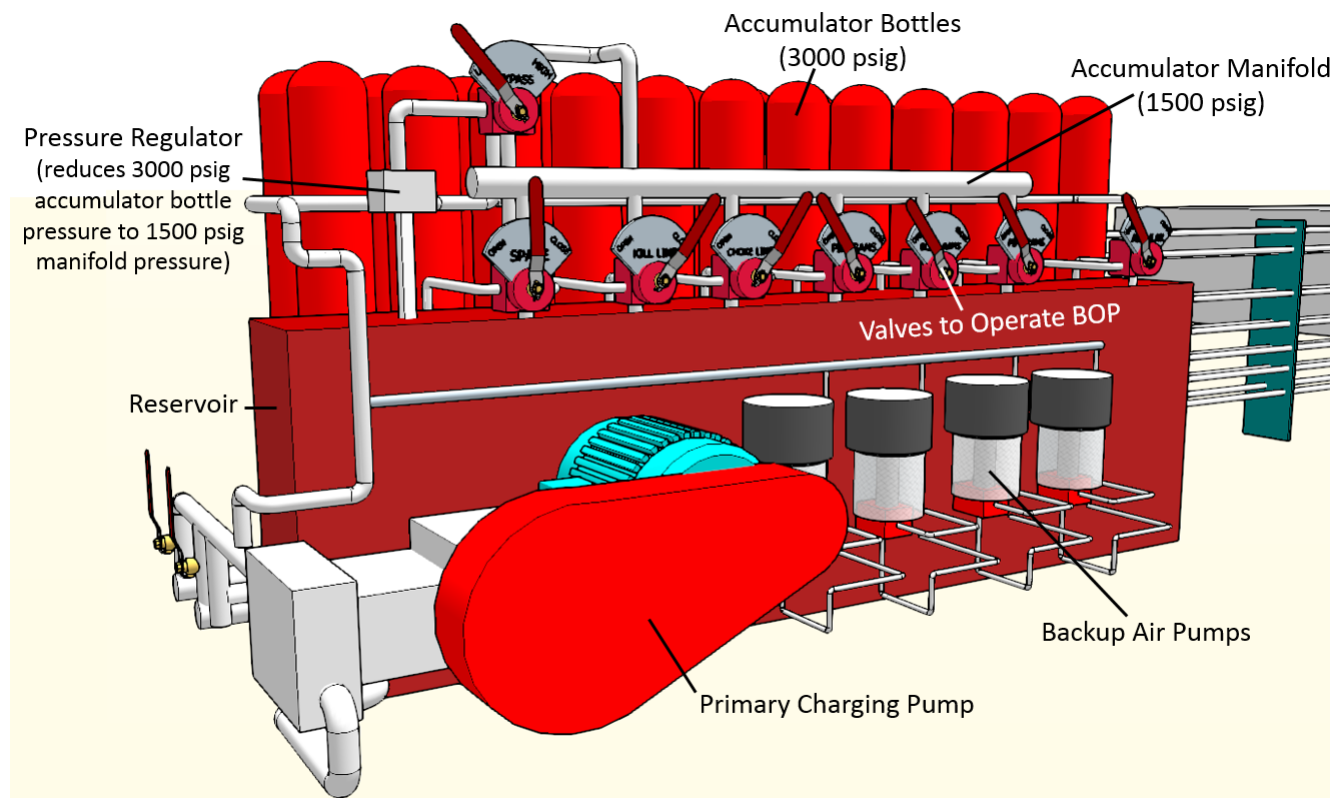
Blowout preventers are hydraulically operated equipment, using high-pressure hydraulic fluid stored in an accumulator.<sup>a</sup> A depiction of the Rig 219 accumulator is shown in Figure 48.<sup>b</sup> Hydraulic fluid at 3,000 psig is stored in the accumulator bottles. That pressure is reduced to 1,500 psig through a pressure regulator for the manifold. Hydraulic fluid in the accumulator manifold is used to function the blowout preventer.

Figure 48. Depiction of the Patterson Rig 219 accumulator. The top valve on the accumulator is the Bypass valve. From left to right, the bottom valves are Spare, Kill Line, Choke Line, Bottom Pipe Rams, Blind Rams, Top Pipe Rams, and Annular Preventer.

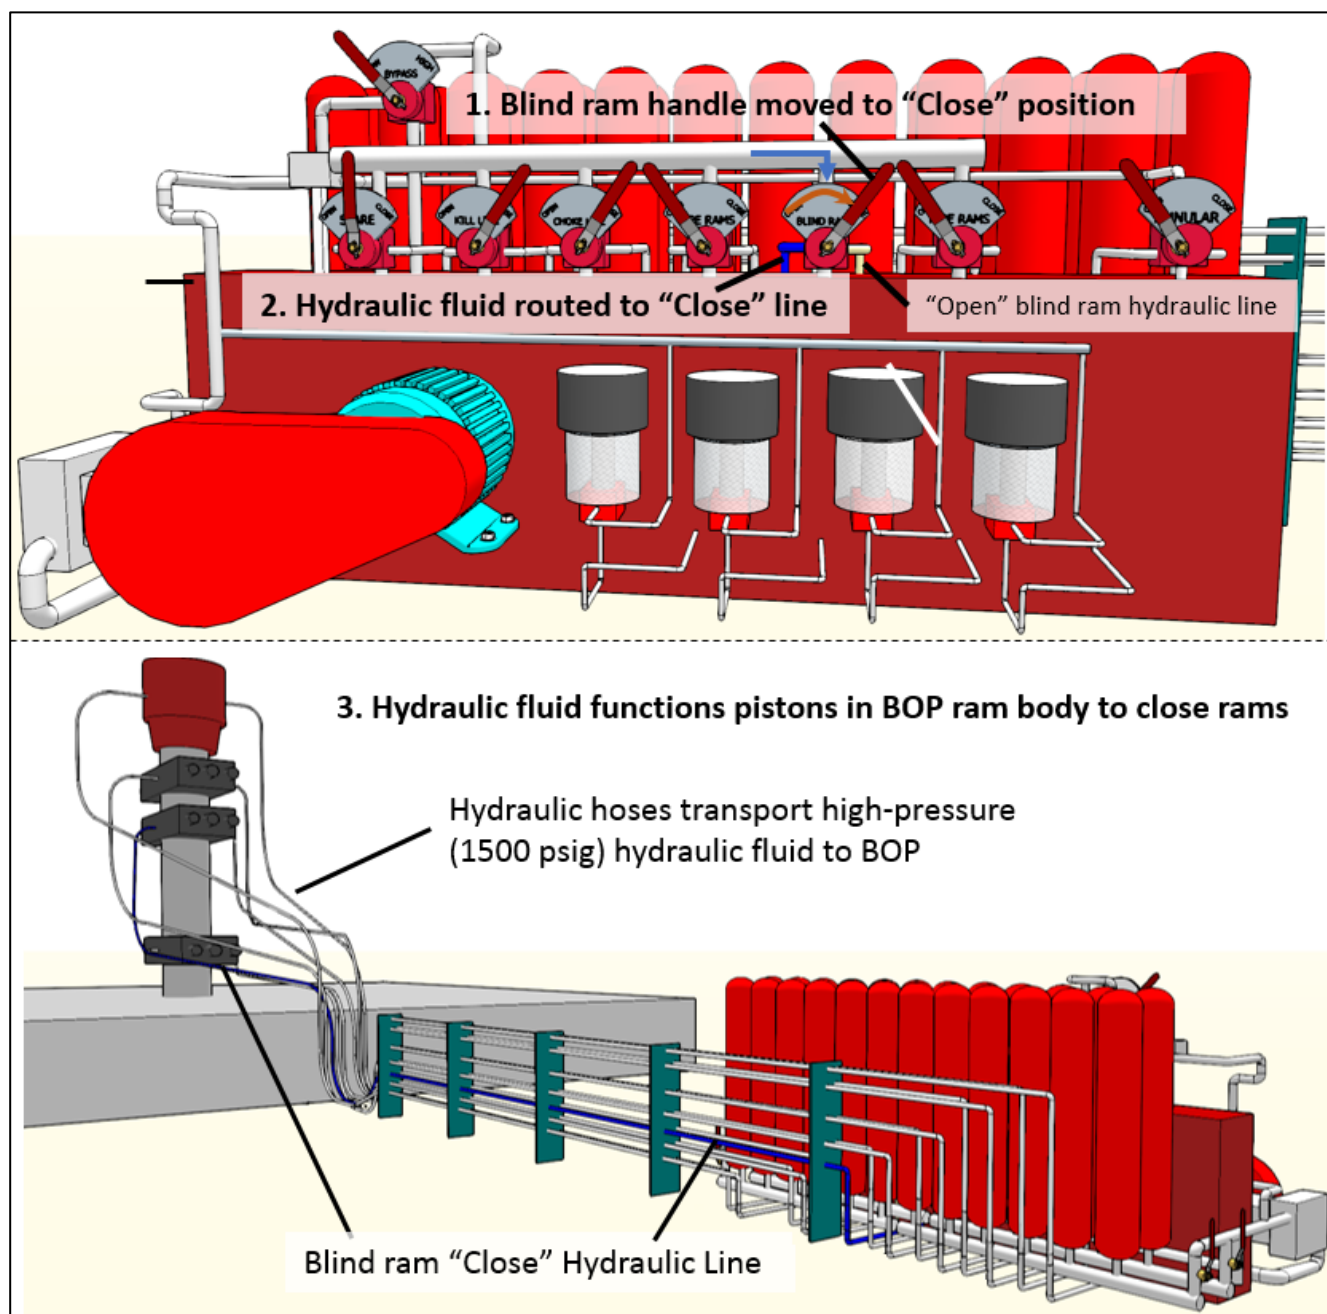
Figure 49 illustrates how the accumulator is used to function the blowout preventer. When a person moves an accumulator handle to its “close” position for, for example, the blind rams, 1500 psig hydraulic fluid from the accumulator manifold is routed to the blind ram “close” hydraulic line, which then moves two pistons inside the ram body to close the rams. The pressurized hydraulic fluid that was in the “open” piston chambers and hydraulic line drains into the accumulator reservoir. When a person then moves the handle to the “open” position, high-pressure hydraulic fluid is routed to the blind ram “open” hydraulic line, which then moves the pistons in the ram body in the opposite direction to then open the rams. The pressurized hydraulic fluid that was in the “close” piston chambers and hydraulic line drains into the accumulator reservoir.

Figure 49. Illustration of how hydraulic fluid in the accumulator functions the blowout preventer blind rams when the blind rams valve is moved to the "close" position. The portion of the hydraulic lines in the support racks is hard piping, and the portion of the hydraulic lines between the support rack and the blowout preventer is flexible hose.

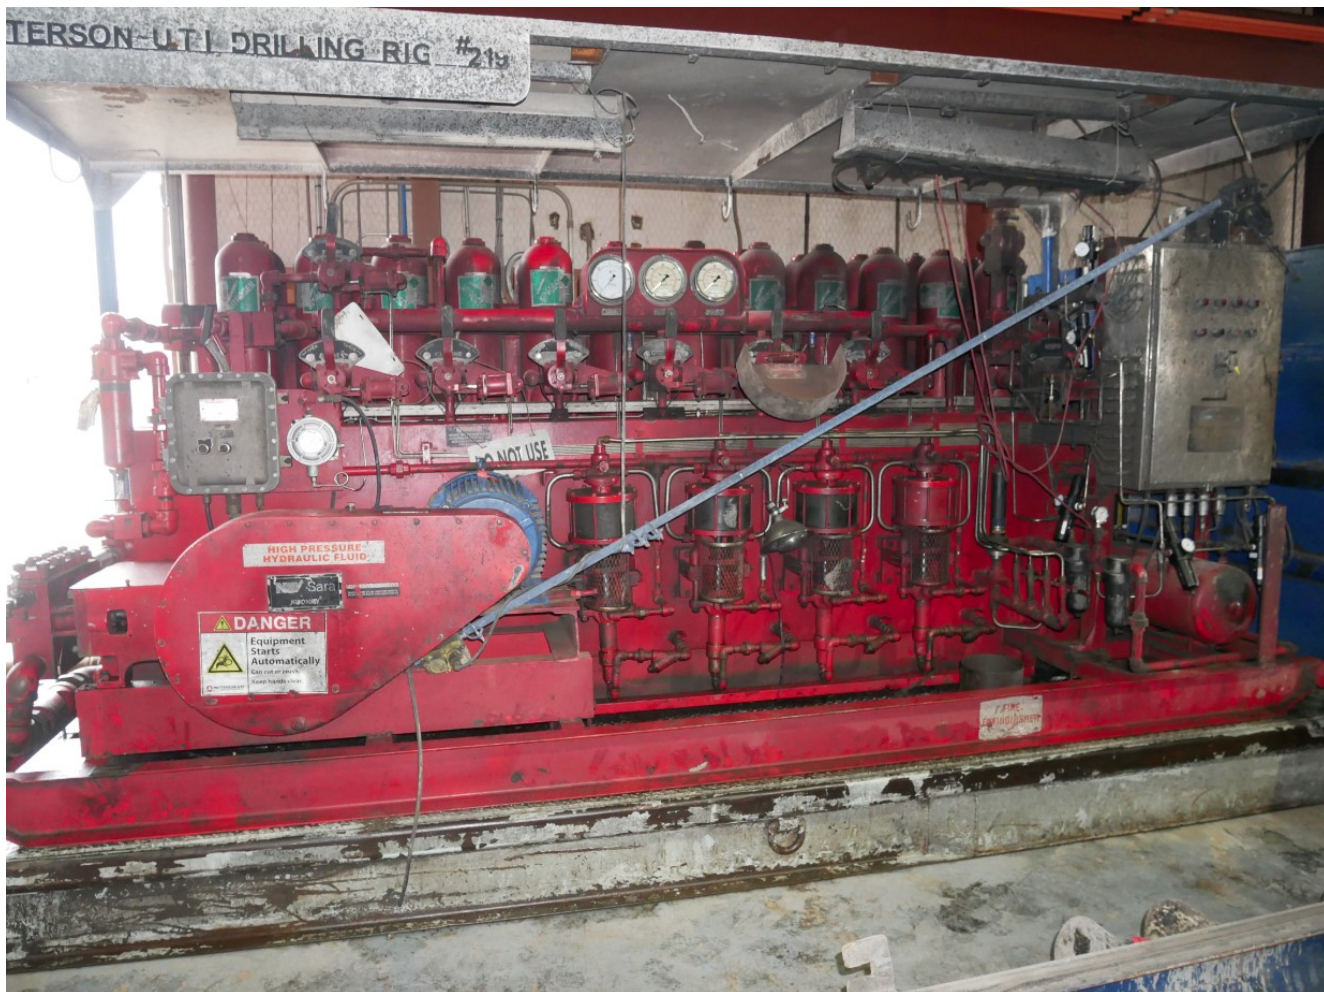
- The accumulator was manufactured by NOV SARA INDIA (P), LTD. It was manufactured in 2008 (Figure A-1).

*Figure A- 1. Photo of Patterson Rig 219 accumulator*

- The accumulator experienced some heat damage from the fire, but heat damage was not excessive. Photos of heat damage are shown in Figure A- 2.

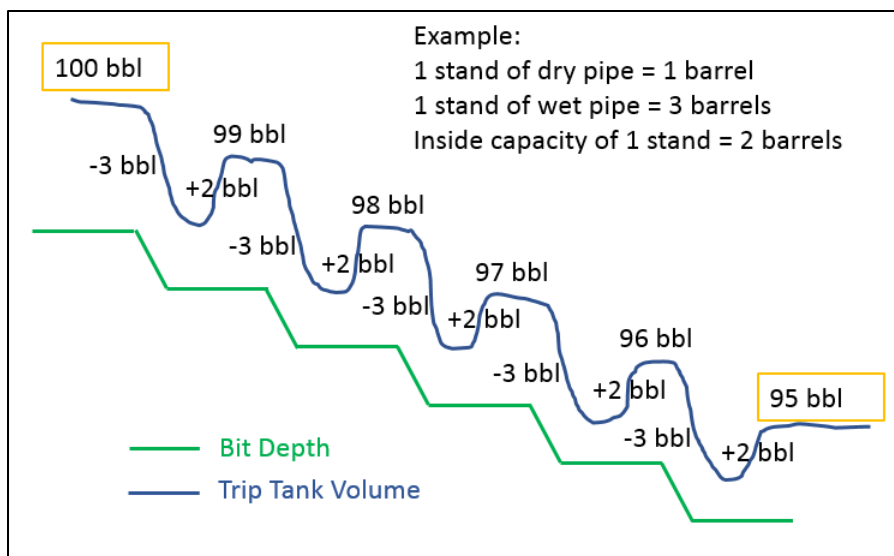
- Figure C- 1 illustrates how a trip tank volume could behave when tripping wet pipe, when the drill pipe contents drain back into the trip tank as shown in Figure C- 2.

Figure C- 1. Example trip tank fluctuation pattern when tripping wet pipe when mud bucket drains to trip tank.

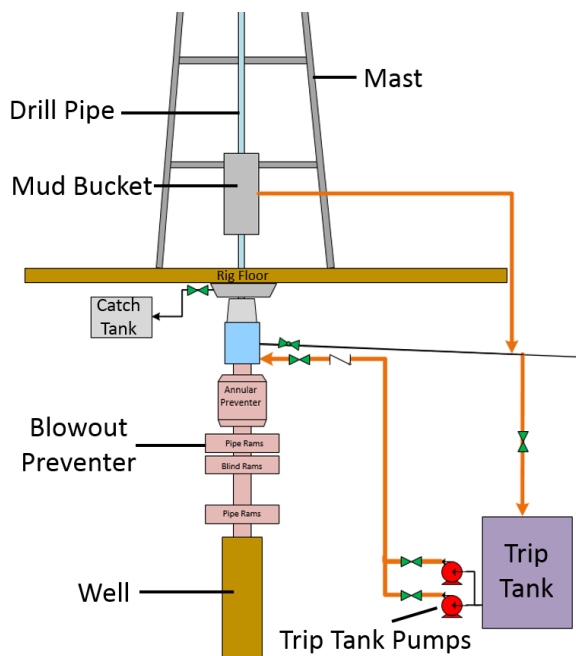
Figure C- 2. Example equipment alignment that could cause the trip tank volume fluctuations shown in Figure C- 1.

- In this example, tripping five stands of drill pipe containing mud (each stand has dry volume of 1 barrel) with the mud bucket draining to the trip tank results in a five-barrel decrease in the trip tank volume. This is a volume reduction of the *dry volume* of the drill pipe stand even though the drill pipe was being pulled “wet.”
- This calculation assumes there is no mud leakage or mud spilled on the drill floor during the tripping operation.
- The *Guide to Blowout Prevention*, created by the company Well Control School (WCS) states:

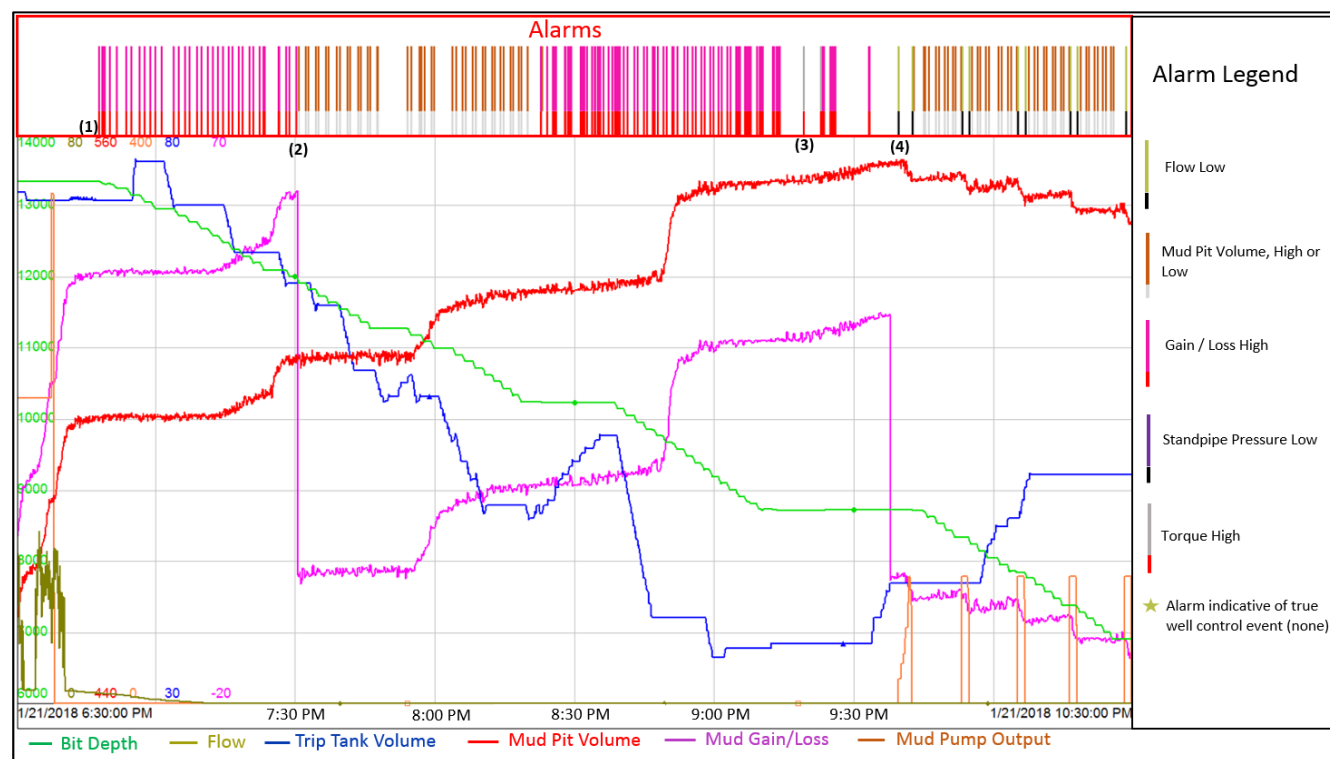
Figure E- 1 depicts what alarms would have been active during this period. Each line on the top of Figure E- 1 does not indicate a separate alarm; instead, each alarm line is simply a recorded data point above the alarm set point in the data provided to the CSB. The figure is to be interpreted that when those lines for that parameter are visible, that alarm would have been active as a continuous beeping. Had the alarm system been on during the tripping operation out of the lateral part of the well on January 21, between 6:45 pm and 10:30 pm, alarms would have activated for Gain Loss High, Total Mud, Flow Low, Standpipe Pressure Low, and Torque (Figure E- 1). While these alarms and set points would have been important during a drilling operation, none were not applicable to the tripping operation in alerting to a well control event. More information about the specific alarms is in Table E- 1.

Figure E- 1. Information from alarm system data, indicating what alarms would have activated between 6:45 pm and 10:30 pm during the trip out of the lateral section, had the alarm system been turned on. Information about the specific alarms is in Table E- 1 below. The numbers in parentheses correspond with the note numbers in Table E- 1.

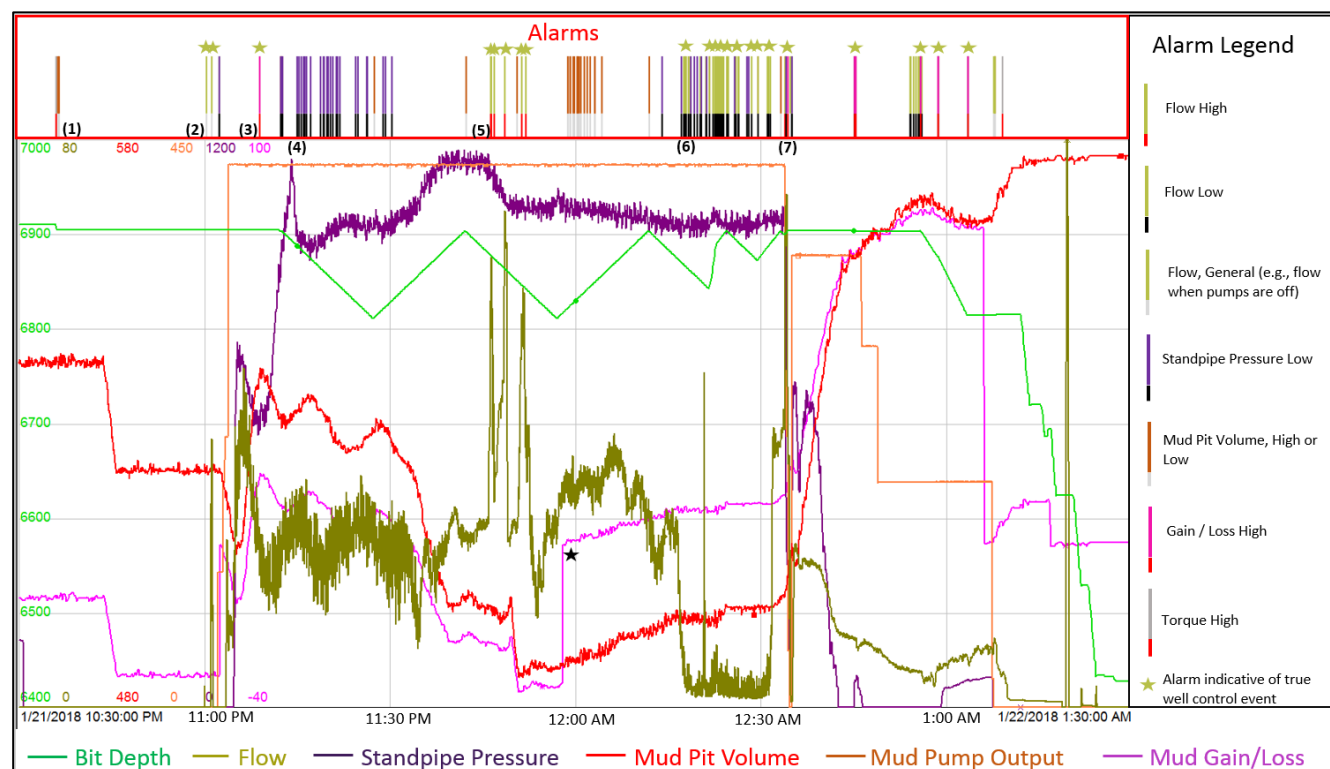
While circulating at the top of the curve, had the alarm system been active, some of the active alarming would have been potentially indicative of the well control event, but the bulk of the active alarming would have been non-critical alarms (Figure E- 2). More information about the specific alarms is in Table E- 2.

Figure E- 2. Information from alarm system data, indicating what alarms would have activated between 10:30 pm and 1:10 am while circulating at the top of the curve, had the alarm system been turned on. Some of these alarms could have alerted to the well control event. Information about the specific alarms is in Table E- 2 below. The numbers in parentheses correspond with the note numbers in Table E- 2.

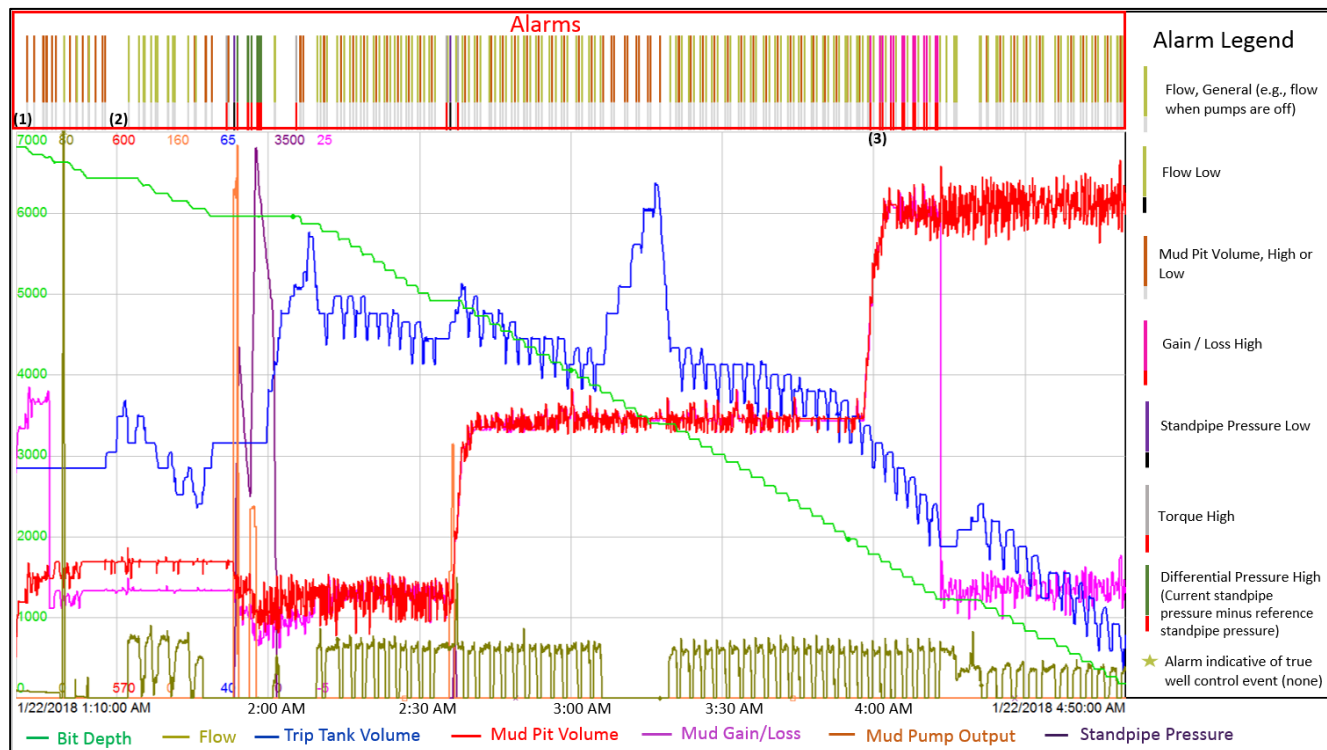
The tripping operation out of the vertical portion of the well occurred between 1:10 am and 4:50 am. During this period, alarms would have activated had the alarm system been on for parameters including mud pit volume, flow, Gain/Loss high, differential pressure, standpipe pressure, and torque. These alarms would have been activated by other rig operations (e.g., transferring mud) or parameters that would be pertinent to the drilling operation but were irrelevant to the tripping operation. As such, all alarming would have been non-critical alarms not indicative of the well control event. No alarms would have activated that warned of a potential well control event during the tripping operation.

Figure E- 3. Information from alarm system data, indicating what alarms would have activated between 1:10 am and 4:50 am while tripping out of the vertical section of the well, had the alarm system been turned on. None of the alarms would have alerted to the well control event. Information about the specific alarms is in Table E- 3 below. The numbers in parentheses correspond with the note numbers in Table E- 3.

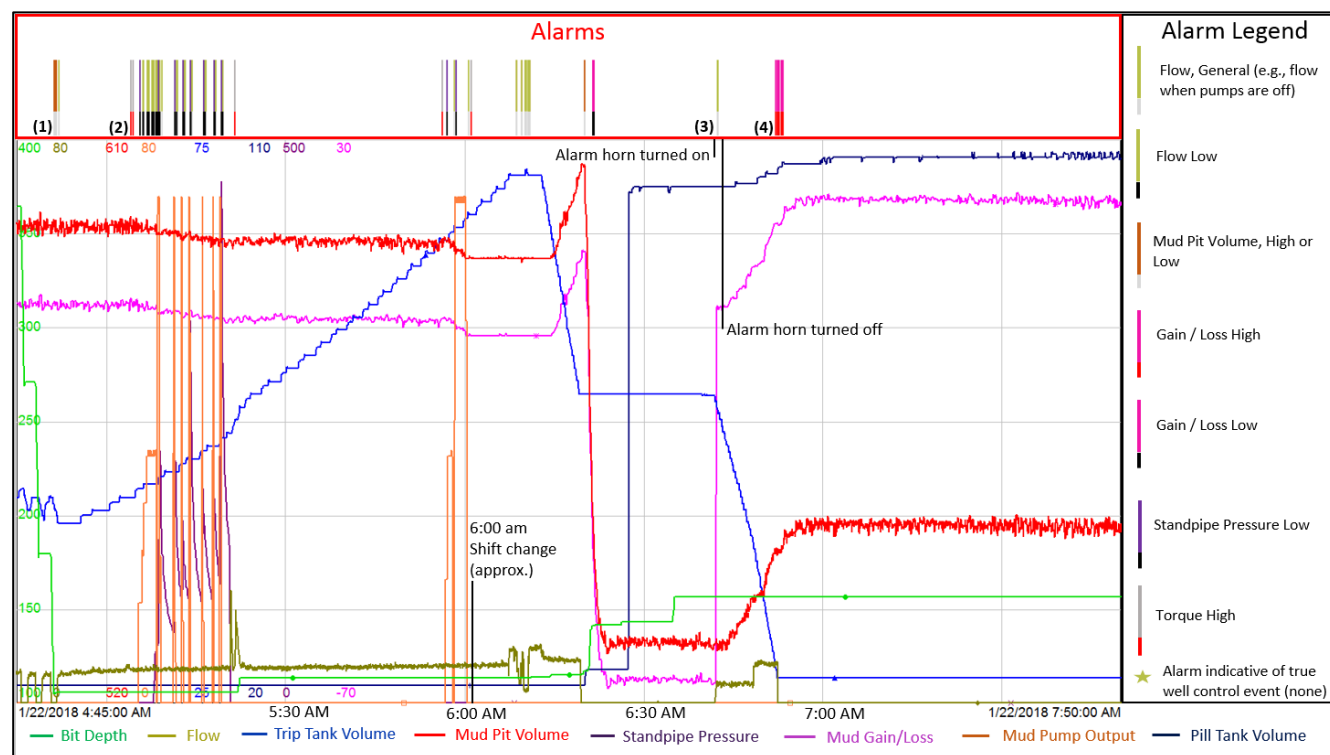
During this period a shift change occurred at around 6:00 am. At 6:42 am, the alarm system was reactivated, likely by the new driller on tour. Non-critical alarms would have been continuously sounding while the alarm system was on. Twenty seconds after the alarm system was turned on, it was turned off again. The alarm horn remained off through the blowout at 8:36 am.

Figure E- 4. Information from alarm system data, indicating what alarms would have activated between 4:50 am and 7:50 am during the rig floor operations, had the alarm system been turned on. None of the alarms would have alerted to the well control event. Information about the specific alarms is in Table E- 4 below. The numbers in parentheses correspond with the note numbers in Table E- 4.

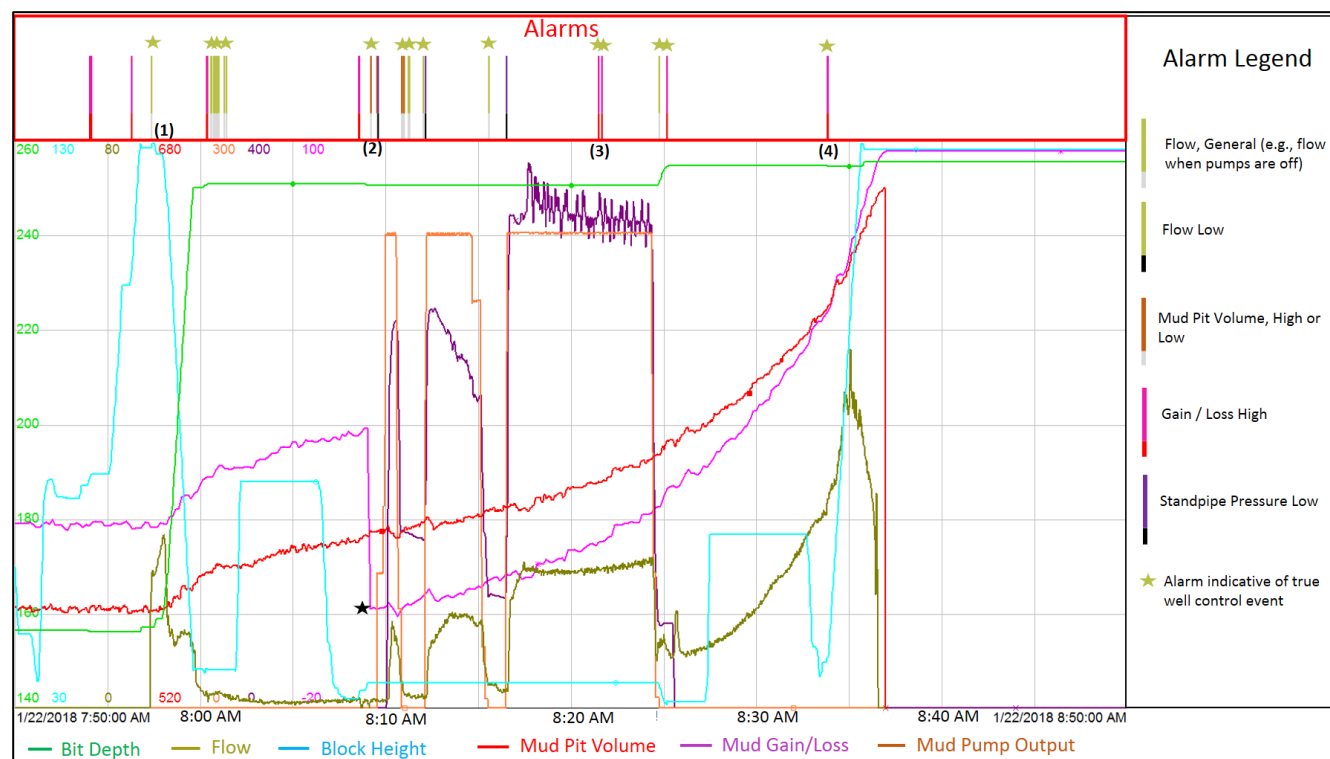
Between 7:50 am and the blowout at 8:36 am, alarms would have activated for Flow, Mud Pit Volume, Standpipe Pressure, Gain/Loss, and Torque. This time, almost all of the alarming would have been indicative of the true well control event.

Figure E- 5. Information from alarm system data, indicating what alarms would have activated between 7:50 am and 8:36 am (blowout), if the alarm system was on. Almost all of the alarms would have alerted to the well control event. Information about the specific alarms is in Table E- 5 below. The numbers in parentheses correspond with the note numbers in Table E- 5.

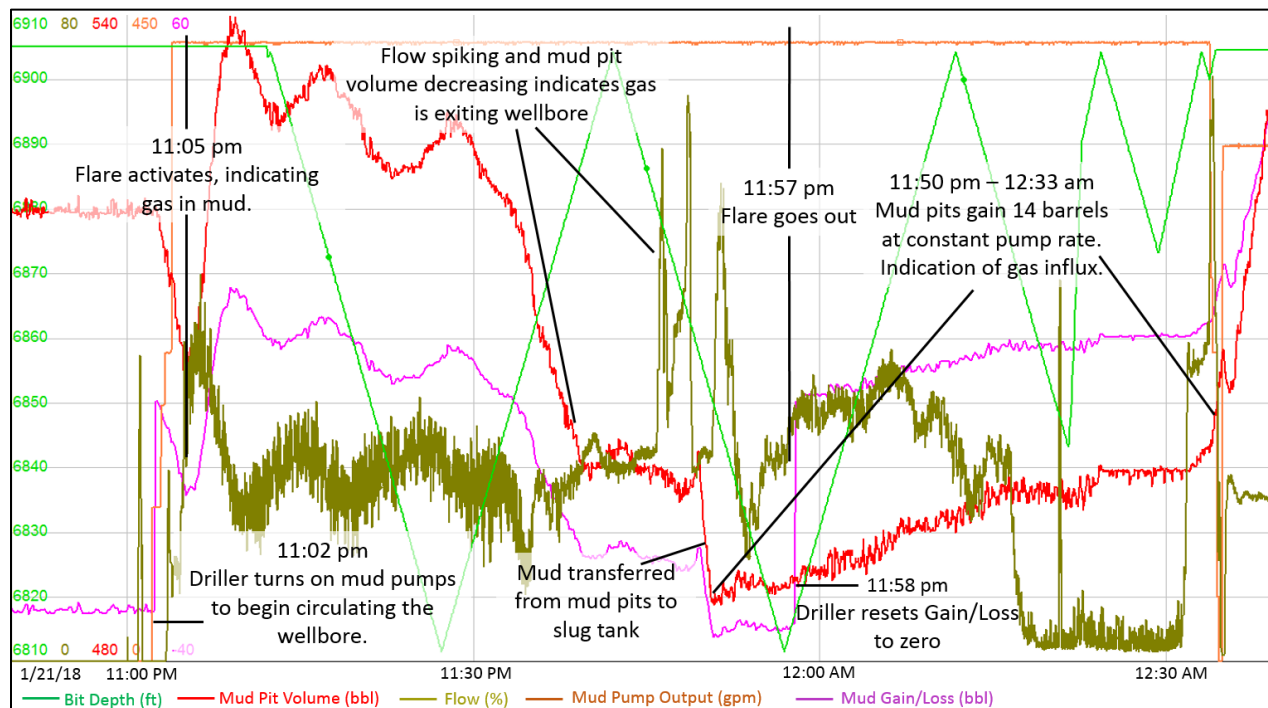
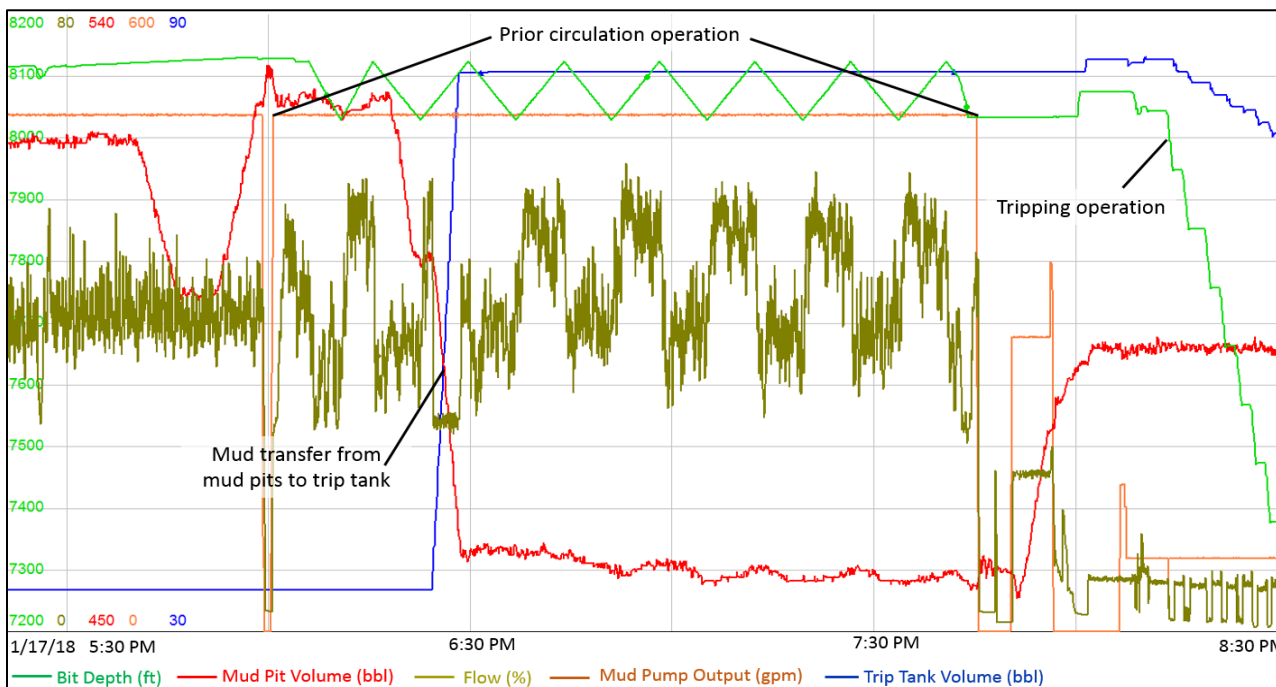
## Appendix F — Comparison of Two Circulation Operations on Well 1H-9

The top graph below shows rig data while circulating the wellbore at the top of the curve. The flare activated while circulating, indicating gas in the mud. Between 11:50 pm and 12:33 am, the mud pits gained 14 barrels while the mud pumps were circulating at a constant pump rate. This pit gain indicates there was a gas influx (kick). For comparison purposes, the bottom graph shows a normal circulation operation performed on January 17, 2018 on Pryor Trust Well 1H-9.
